St. Mary's College of Maryland

MASTER PLAN – PHASE 1 SUMMARY

Landscape Needs Analysis and Existing Conditions Assessment

November 1st, 2012

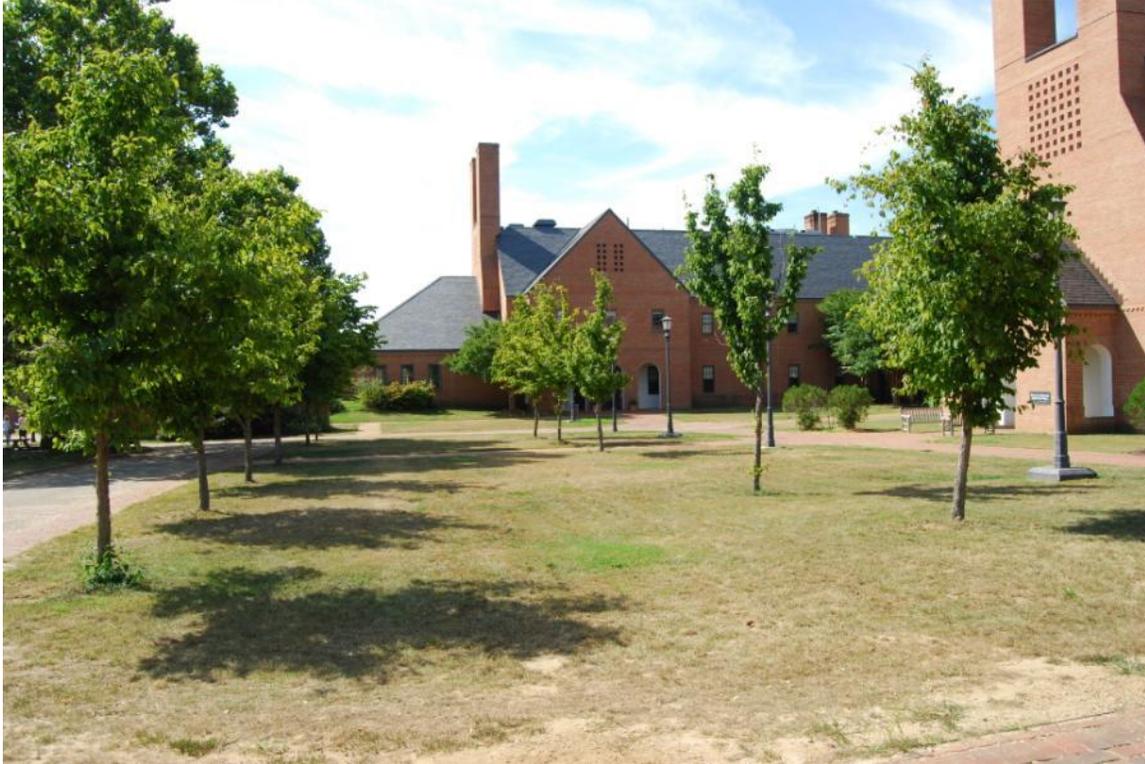
The picture below shows the area in front of Schaefer/Glendening area where turf and canopy has struggled due to poor soil and perhaps lack of irrigation.

- Limit use of ground covers.
- Continue focus on trees and turf
- Manage and maintain current healthy shrub beds, renovate deteriorated shrub beds, add shrub beds to North Campus (as funds and labor allow for it)
- Conduct a study on soils and their effects on tree health (especially in North Campus)
- Irrigation – preferably with harvested stormwater
- Use native and adaptive plants but allow flexibility to incorporate non-native plants in cultural landscapes when necessary to reinforce the structure of spaces.

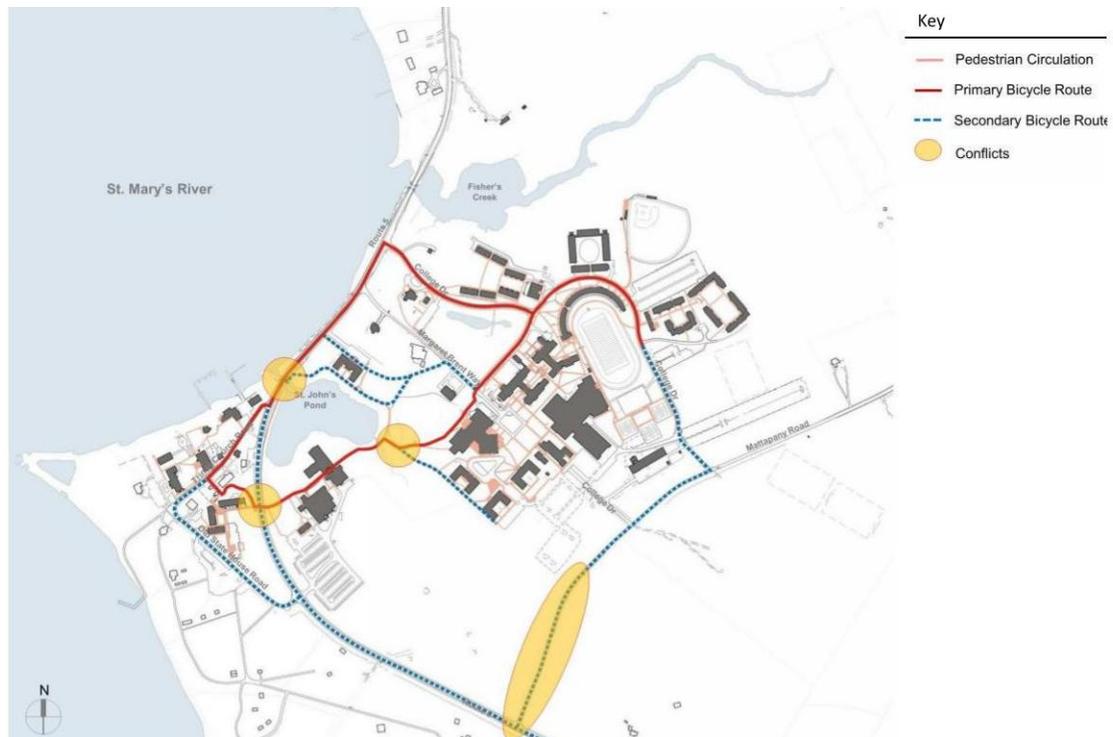
Bicycle: As the campus grows and distances increase between destinations bicycle use increases, which tends to intensify conflicts between bicyclists and pedestrians sharing common pathways. Conflicts arise from the speed of bikes and volume of traffic during peak use times. During those instances that bicycles share the roads similar conflicts arise. While it is relatively safe to share campus roads where traffic is infrequent and slower, it is of some concern that bicyclists share Rt.5 with vehicles with no dedicated bike lanes. In other instances, bicyclists have created new informal paths but these paths are often unpaved or through unsecure areas or unsafe terrain. The diagram below shows pedestrian and bicycle circulation and three main areas of conflicts.

- Provide additional bike racks throughout campus using the bike rack at the River Center as one of the campus standards.
- Within the main Campus: Bike trails parallel to or weave between pedestrian cord where possible – a particular concern is the intersection at St. John’s Pond and at Campus Center
- Along major roads: Bike trail or dedicated bike lane on Rt. 5 and along Mattapanay with clearly identified crossings. Explore use of chicanes to slow down bicycle traffic preparing to cross Rte 5 or bicycle traffic at Campus Center courtyard entrances.
- Materials: Avoid gravel or mulch; wood decking should be grooved to provide traction when wet. Asphalt is best for bicycles but brick is acceptable.

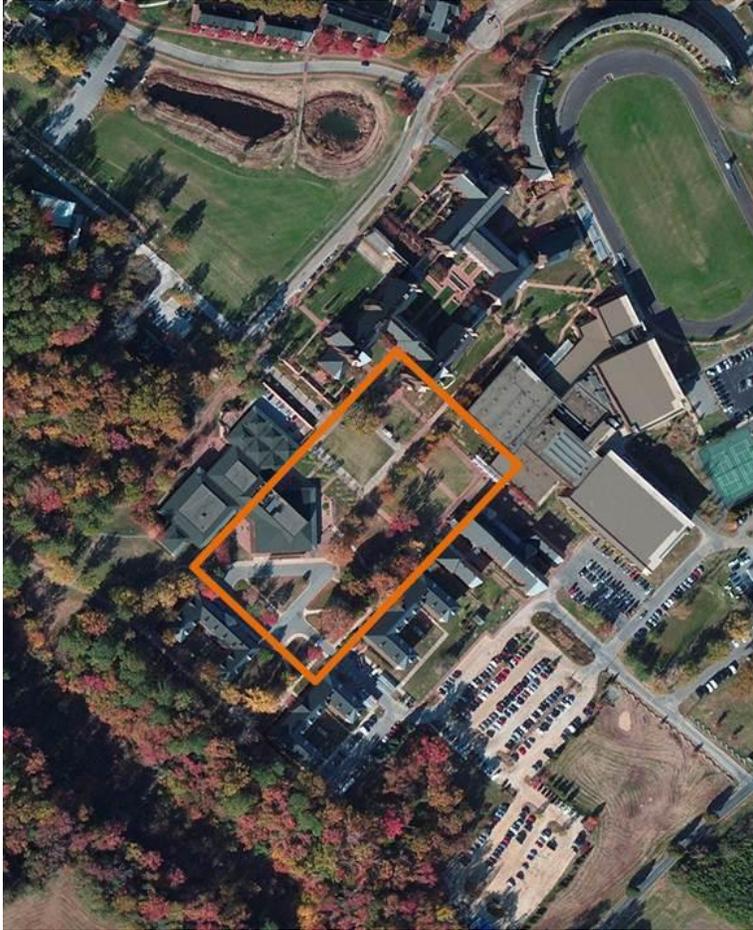
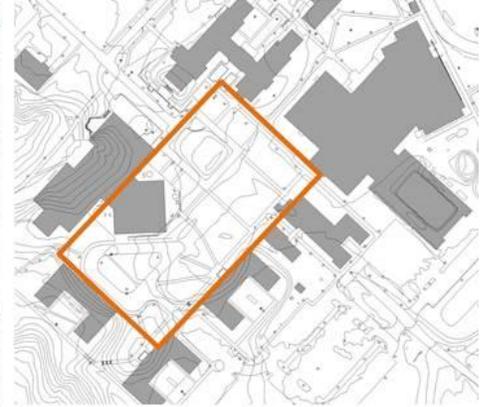
CONCEPTUAL PROJECTS –
MONTGOMERY QUAD AREA

There are also Campus Places that are not so well-formed, well-loved and well-used but have much potential for transformation. One example is the area enclosed by Montgomery Hall, Dorchester/Caroline/Prince George’s Halls, Glendening Hall, Schaefer Hall, and the O’Brien ARC. This area has been identified as one of the major areas of focus for the master plan effort. In addition to framework and scale issues, this Quad lacks mature canopy and has poor soil. However, there are opportunities for strong axial connections and views to the river and to other parts of campus, place making and improvements to edges and redefining centers. Other examples are the Townhouse Crescent (where there are private gardens but no outdoor common space), and Waring Commons (which needs more trees).

- Define and enhance places
- Plateau
- Soils

MVLA has done a preliminary analysis of the needs and opportunities of some of these areas. As there are several directions from which to approach the solution we will provide strategies and recommendations for review in Phase 2.

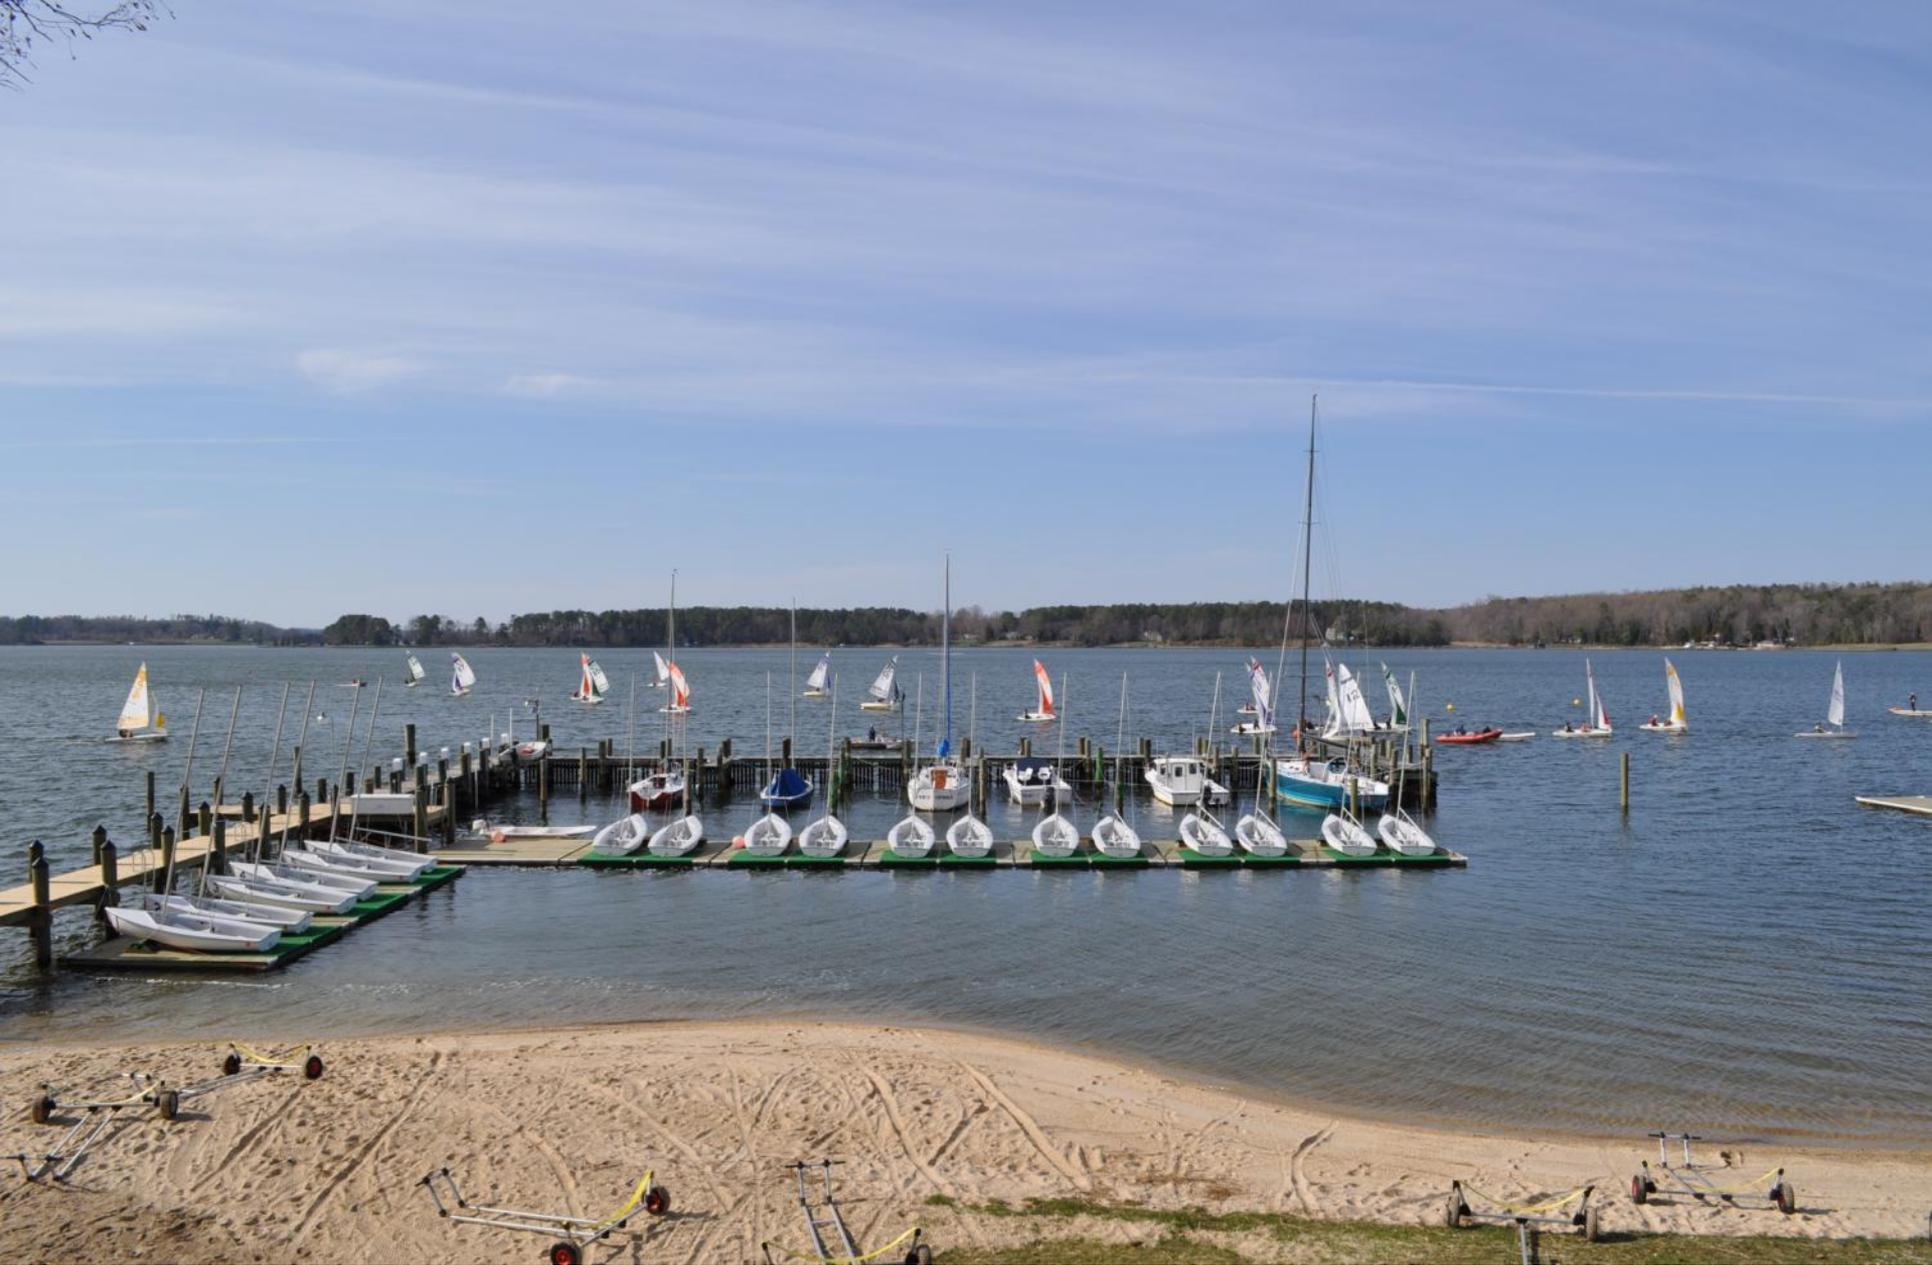
PRECINCTS AND PROJECTS

(project numbers are shown within each area)

**WATERFRONT
GATEWAY**

1 - 5

**NORTH
CAMPUS**

31 - 43

**HISTORIC
CAMPUS**

16 - 19

**CENTRAL
CAMPUS**

20 - 30

**AGRARIAN
GATEWAY**

6 - 10

**HISTORIC
GATEWAY**

11 - 15

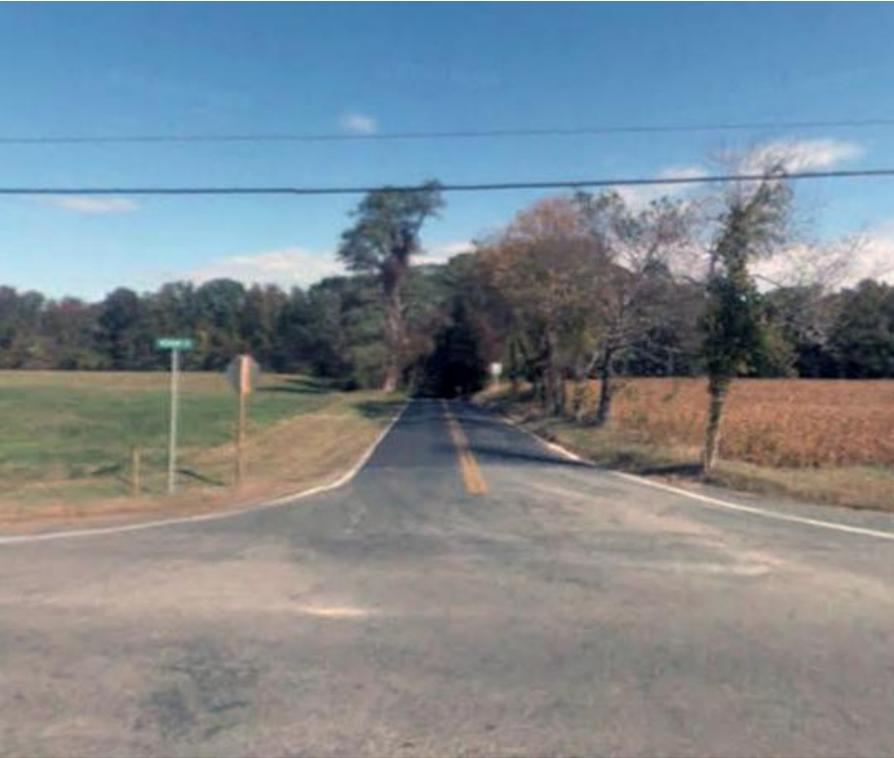
AGRARIAN GATEWAY PROJECTS

- 6. Path/trail to parallel Mattapan
- 7. Traffic calming - Crosswalks
- 8. Landscape improvements in Gateway-Entry Zone, including hedgerow
- 9. Reduce to one entry, mark Entry
- 10. Mark Gateway

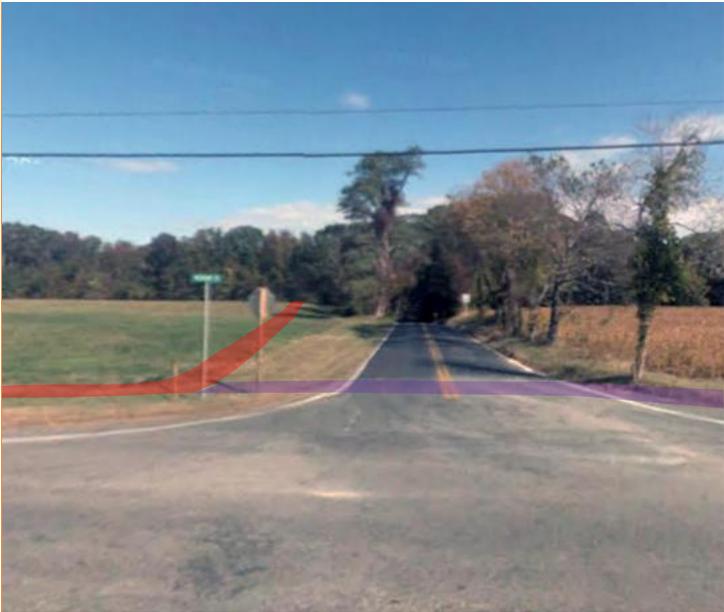
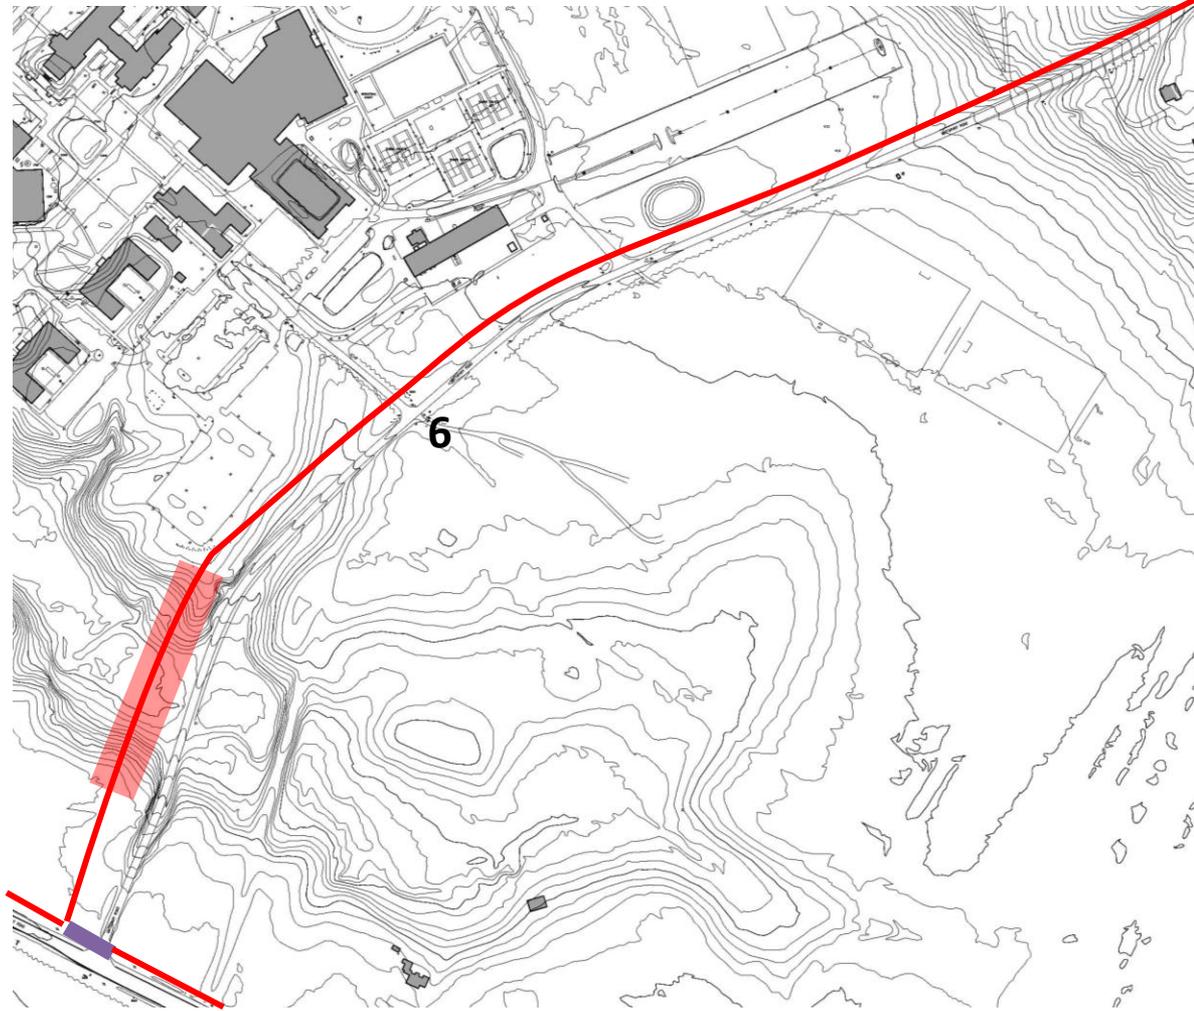
RECREATIONAL TRAIL

- Extension of regional recreation path along Mattapan
- Bridge/boardwalk may be needed

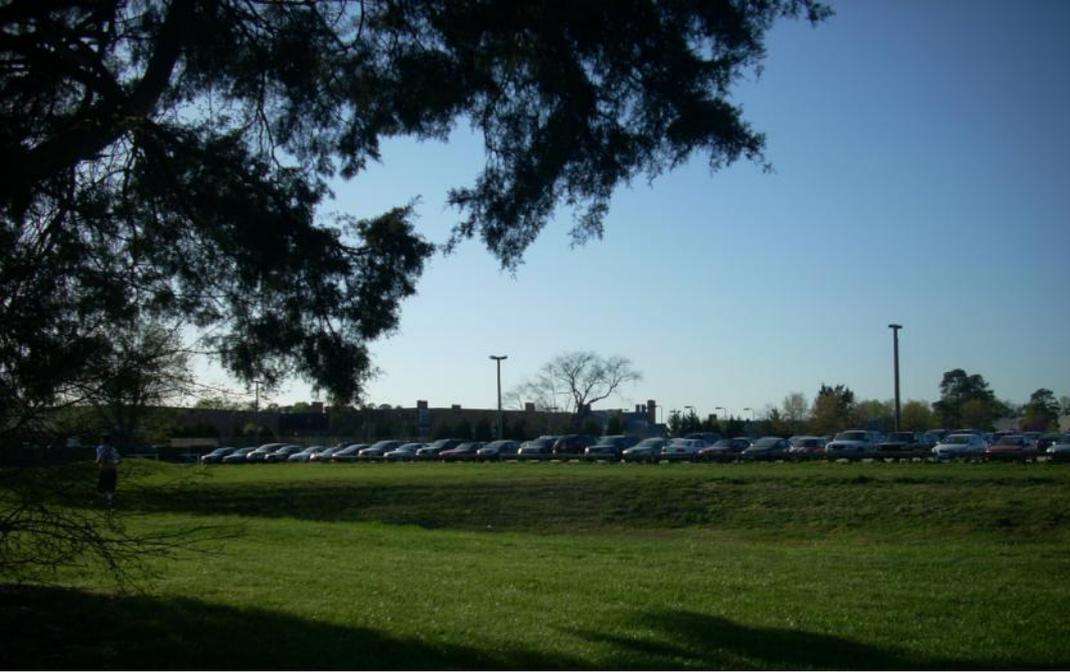
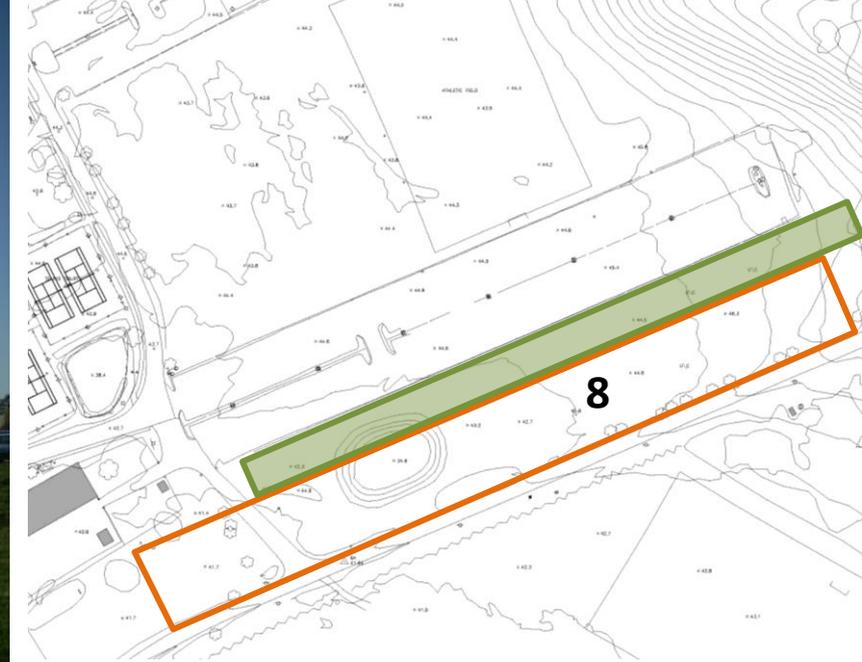
MATTAPANY ARRIVAL/SCREENING

- Mattapany provides a historic and scenic drive into the College
- The beginning and end of the road is flanked by woodland but opens up along College property.
- First view of the College is Guam parking lot
- There are remnants of a hedgerow but not continuous and provides no screening.
- Existing reforestation planting exists east of the lot and should be extended

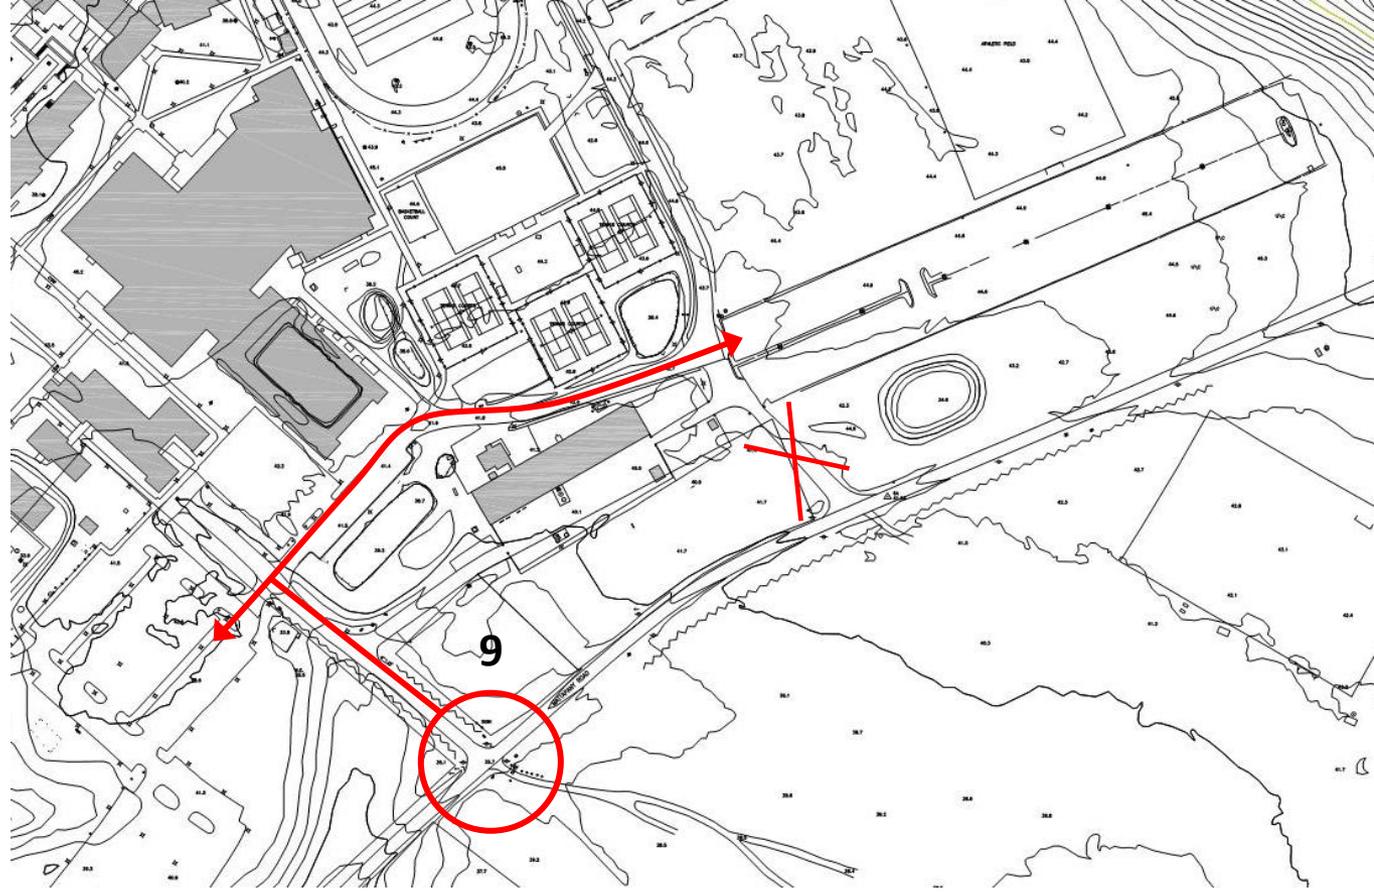
MATTAPAN Y ENTRANCE

- Eliminate existing Mattapan y Entrance
- Route Mattapan y parking lot traffic through existing south entry

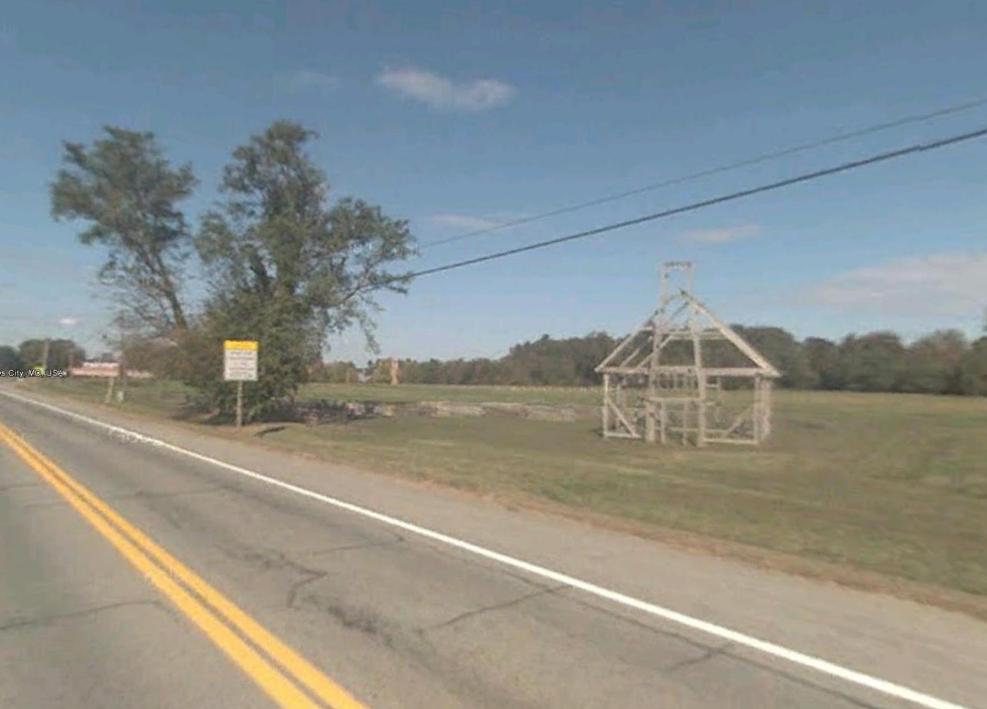
HISTORIC GATEWAY PROJECTS

11. Mark Entry
12. Dedicated bike path on shoulder
13. Crosswalks
14. Mark Gateway
15. Landscape improvements in Gateway-Entry Zone

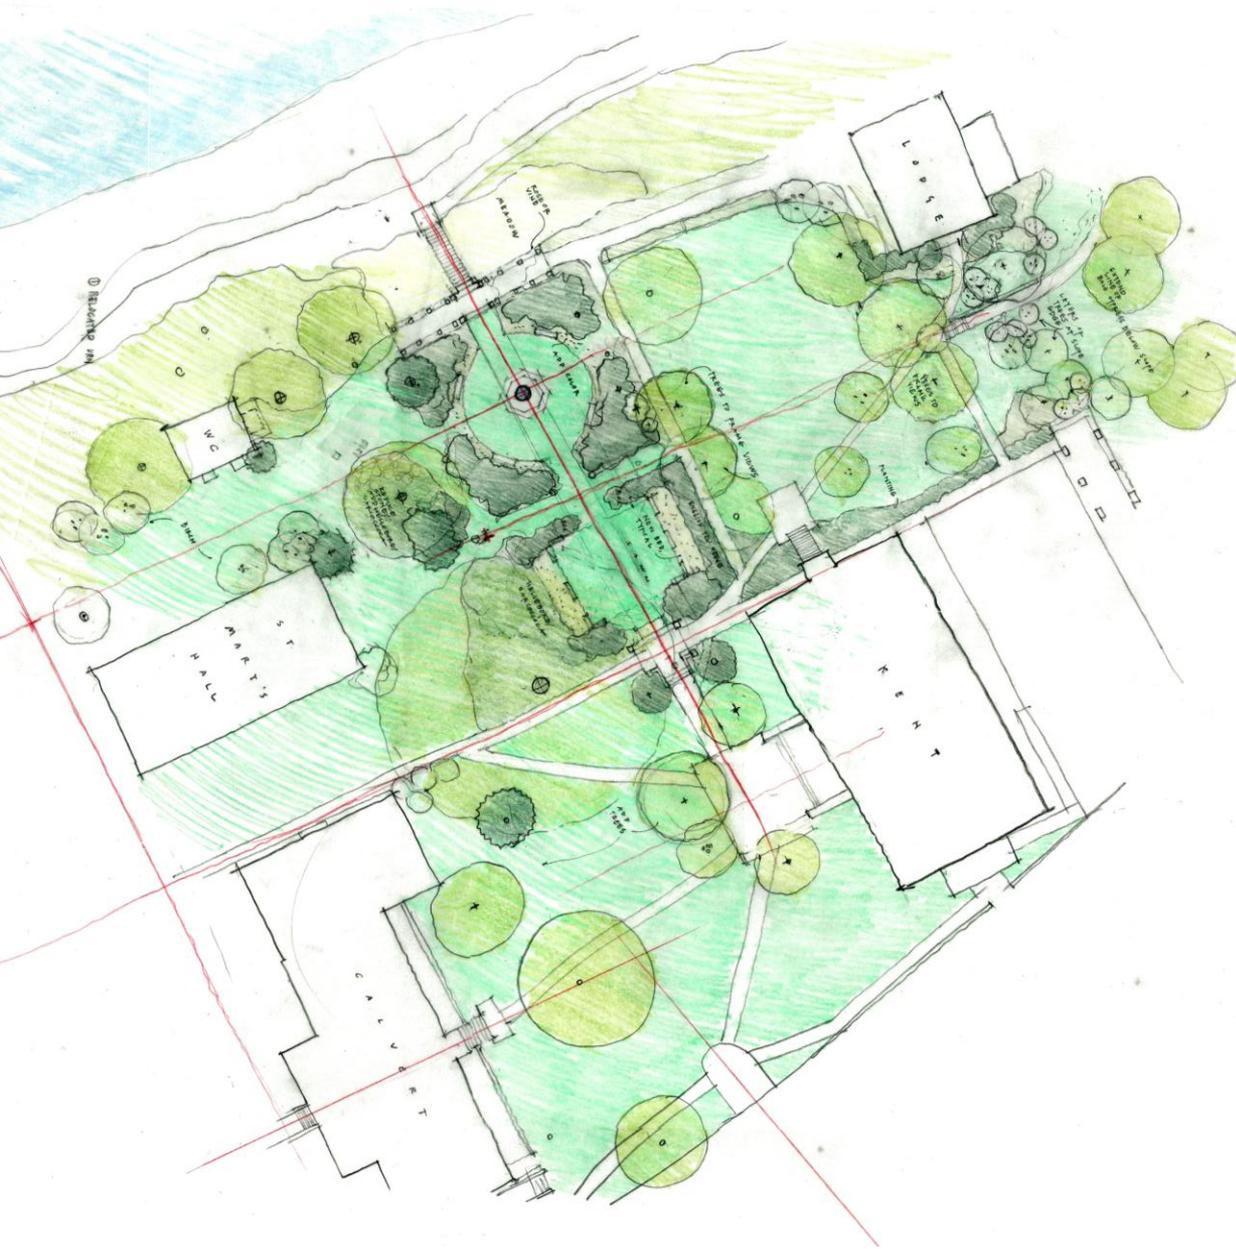
GARDEN OF REMEMBRANCE

- Retain existing plant material where appropriate
- Planting revisions to be guided by historical plan
- Enhance connections with axial relationships and improved focal points
- Create spaces that accommodate variable uses

- 1 Remove drop-off turnaround
- 2 Extend lawn
- 3 New trees frame lawn
- 4 New brick walk
- 5 3' wide gravel walk / bed edge
- 6 Brick seating terrace
- 7 Bluestone stepping stones
- 8 Bench on alignment of State Home
- 9 Indoor / Outdoor rugs on porch
- 10 Rectory bed (8' deep)
- 11 4' hedge (Viburnum 'Conoy')
- 12 Virginia Cedars
- 13 Bluestone stepping stones under walnut tree
- 14 Evergreen screen (Viburnum 'Allegheny')
- 15 Extend Nandina bed
- 16 Renovate lawn
- 17 Connect driveway to future parking at Anne Arundel
- 18 Remove volunteer trees

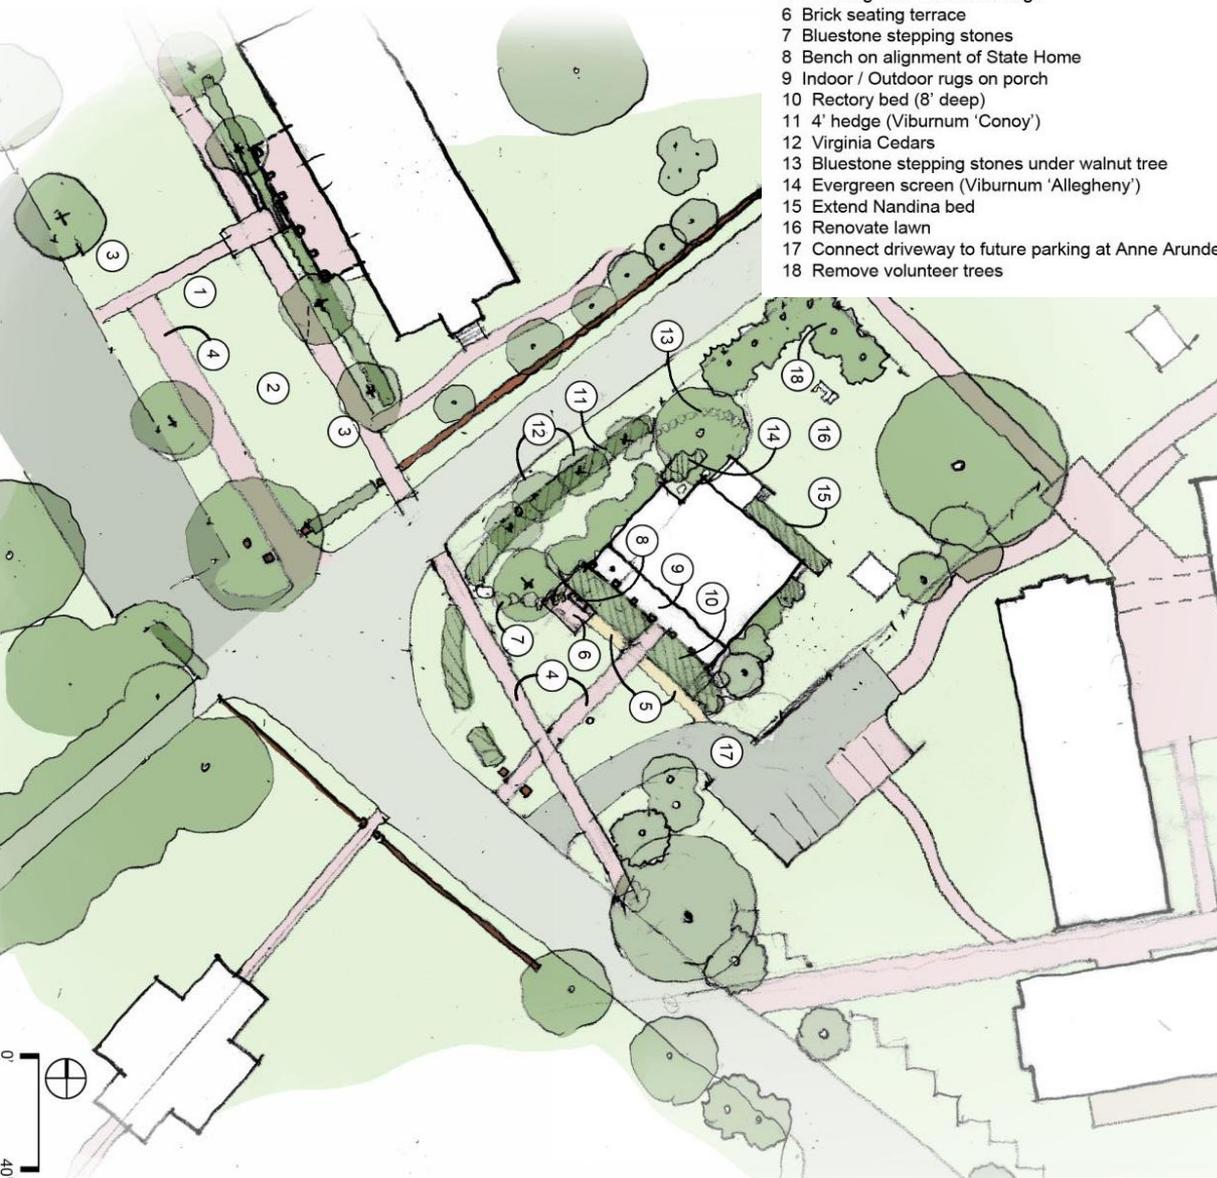
CALVERT LAWN AND RECTORY

- Add seating areas and walks
- Extend and renovate lawn
- Add trees, hedge plantings
- Remove invasive plantings
- Connect driveway to AAH parking

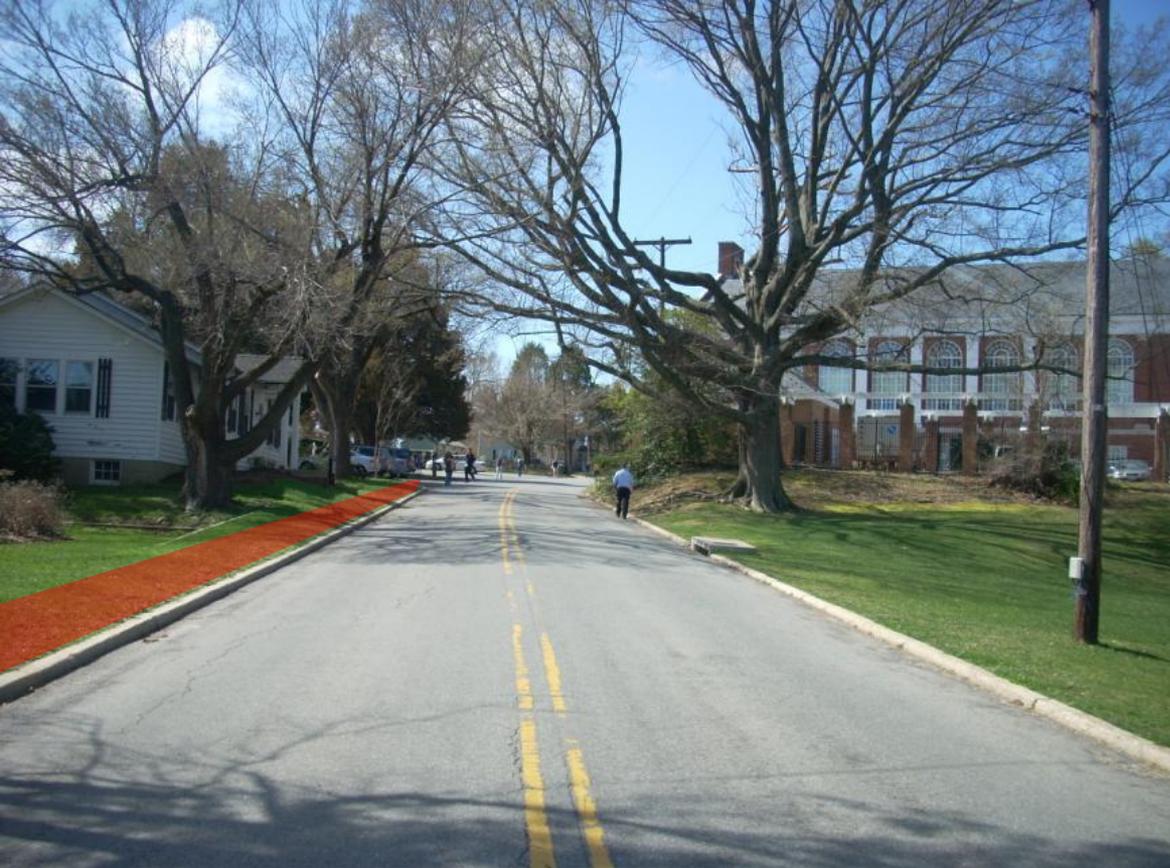
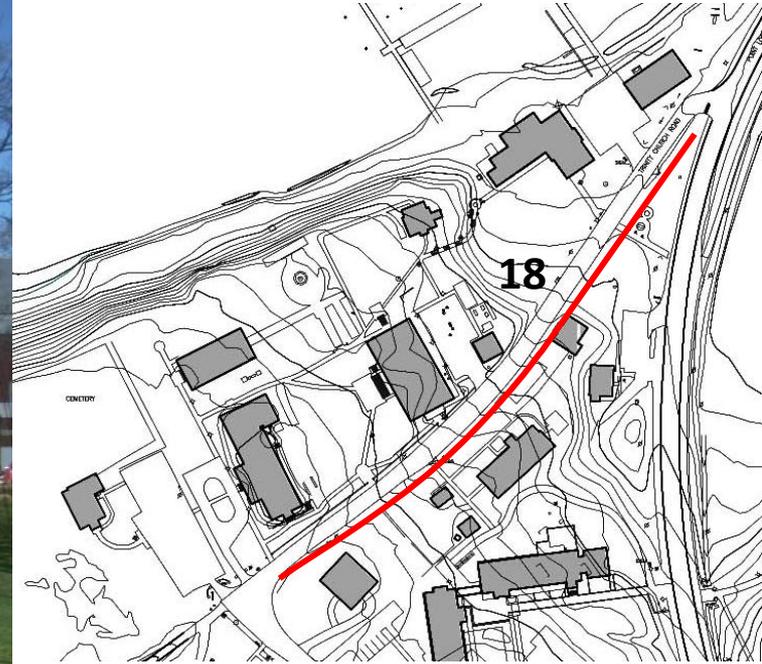
TRINITY CHURCH ROAD

- Add brick walk on one side of Trinity Church Road to create a more pedestrian friendly zone

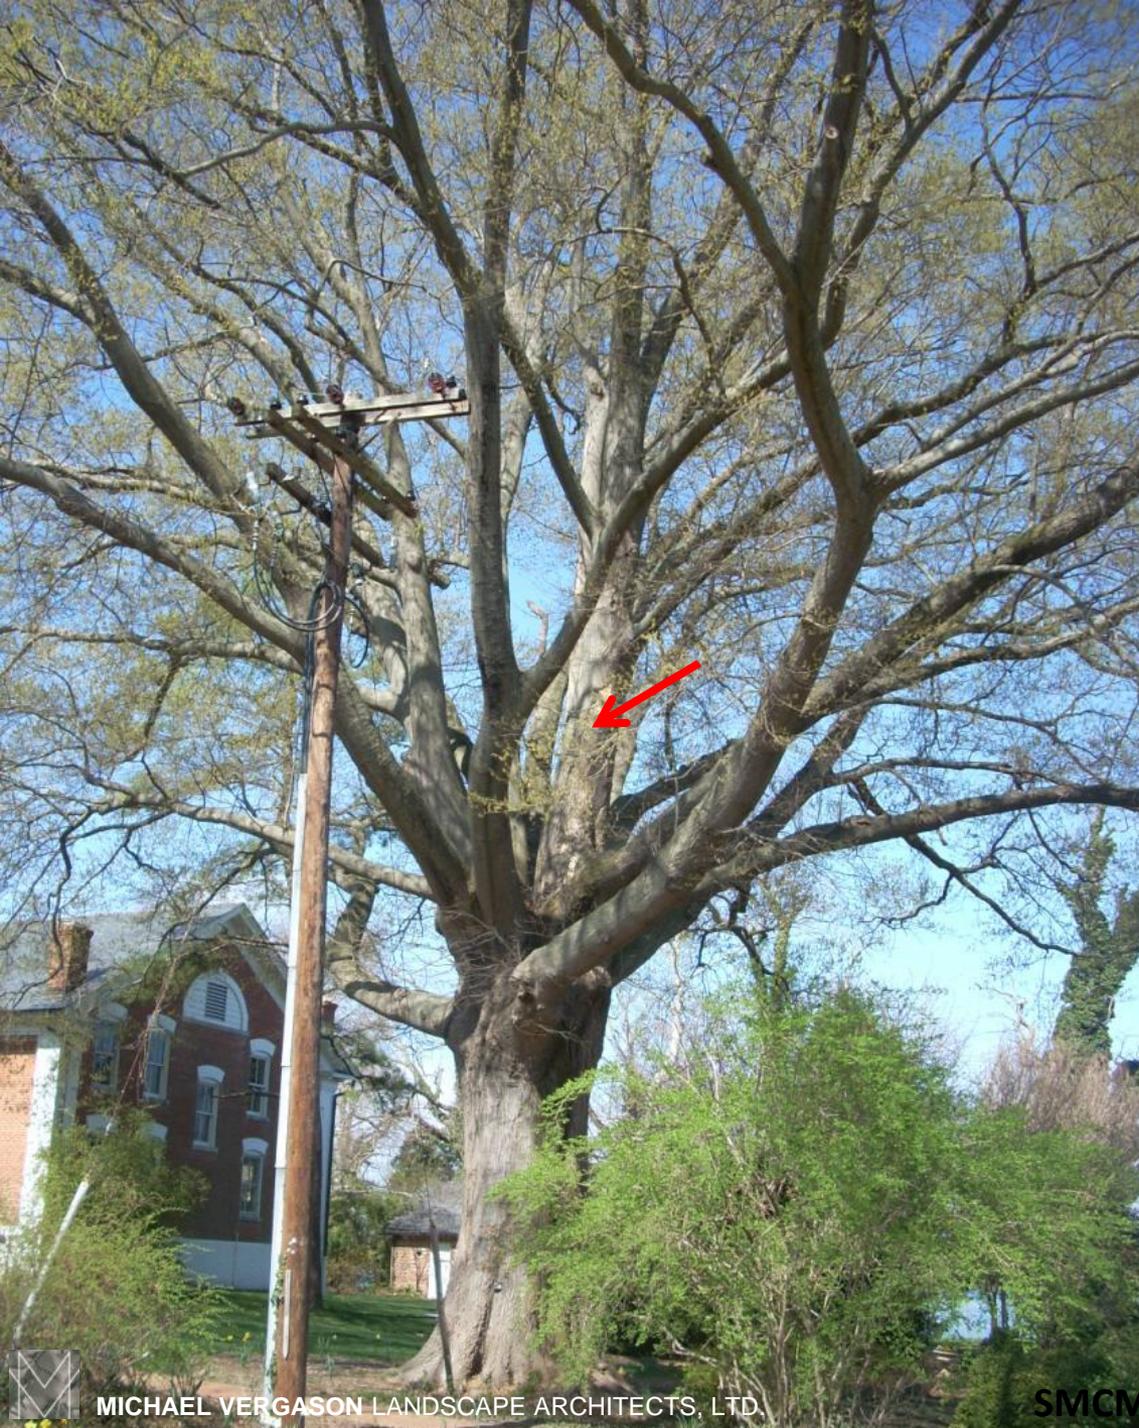
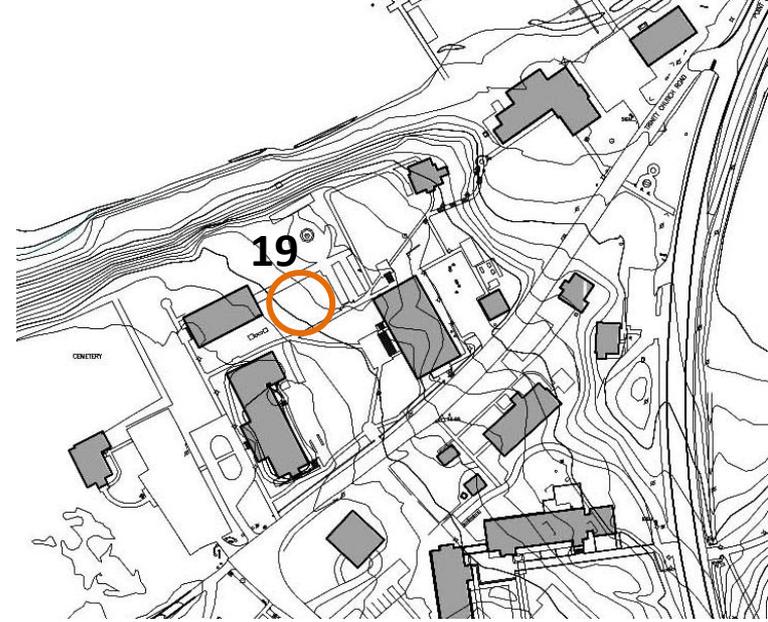
MONITOR NOTABLE TREES' HEALTH

- Notable oak tree - diseased and in decline

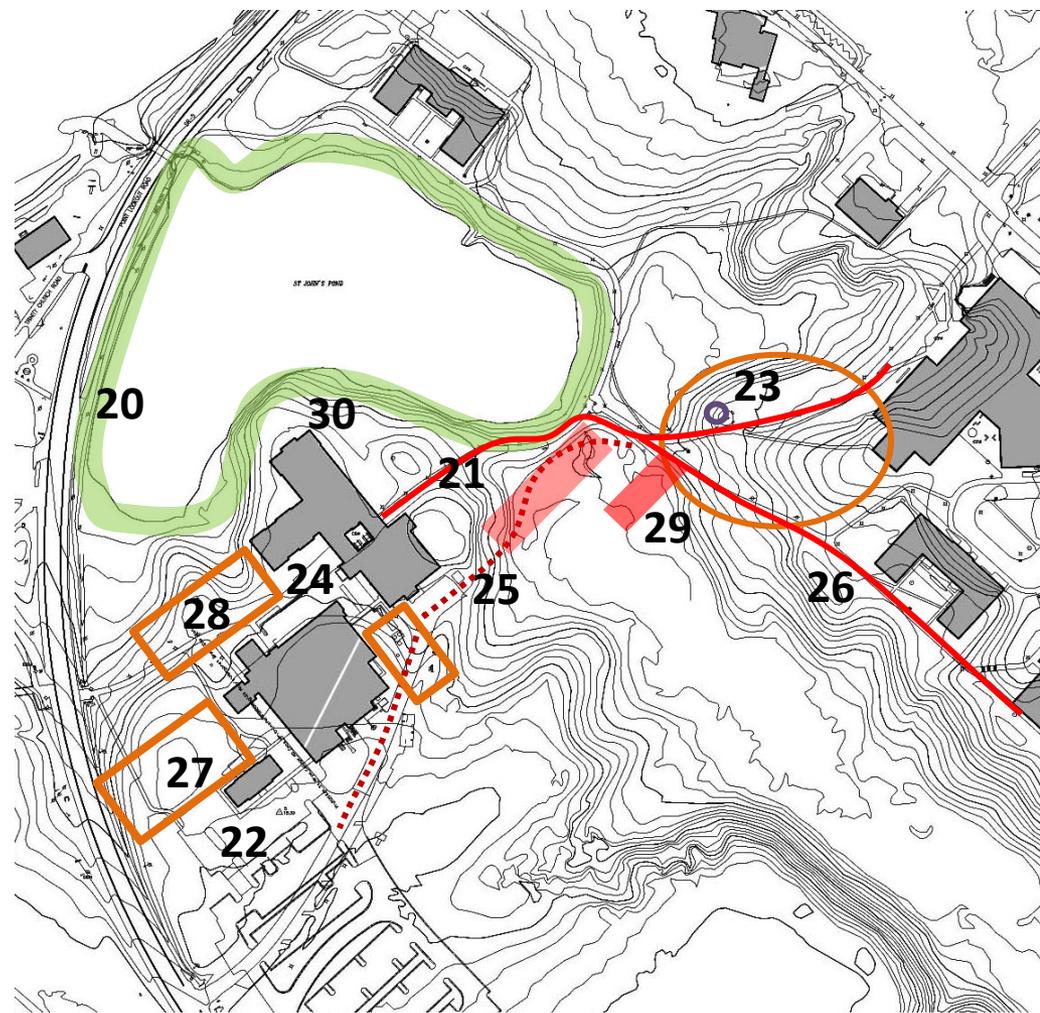
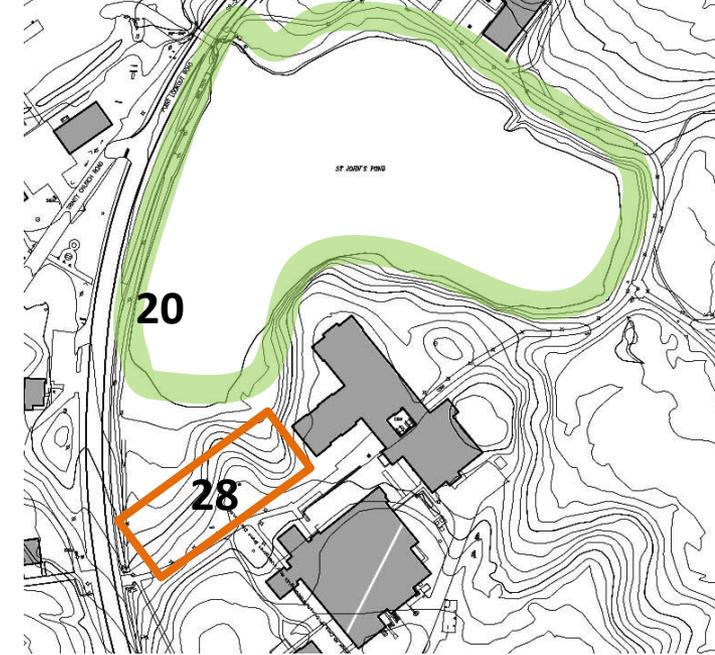
BUFFER, LAWN AND TREES

- Rolling lawn provides informal gathering place – potential for creating permanent space or allow spontaneous gathering
- Edge of reforestation area requires invasives clearing
- Ginkgo mulch rings should be connected to create one continuous bed

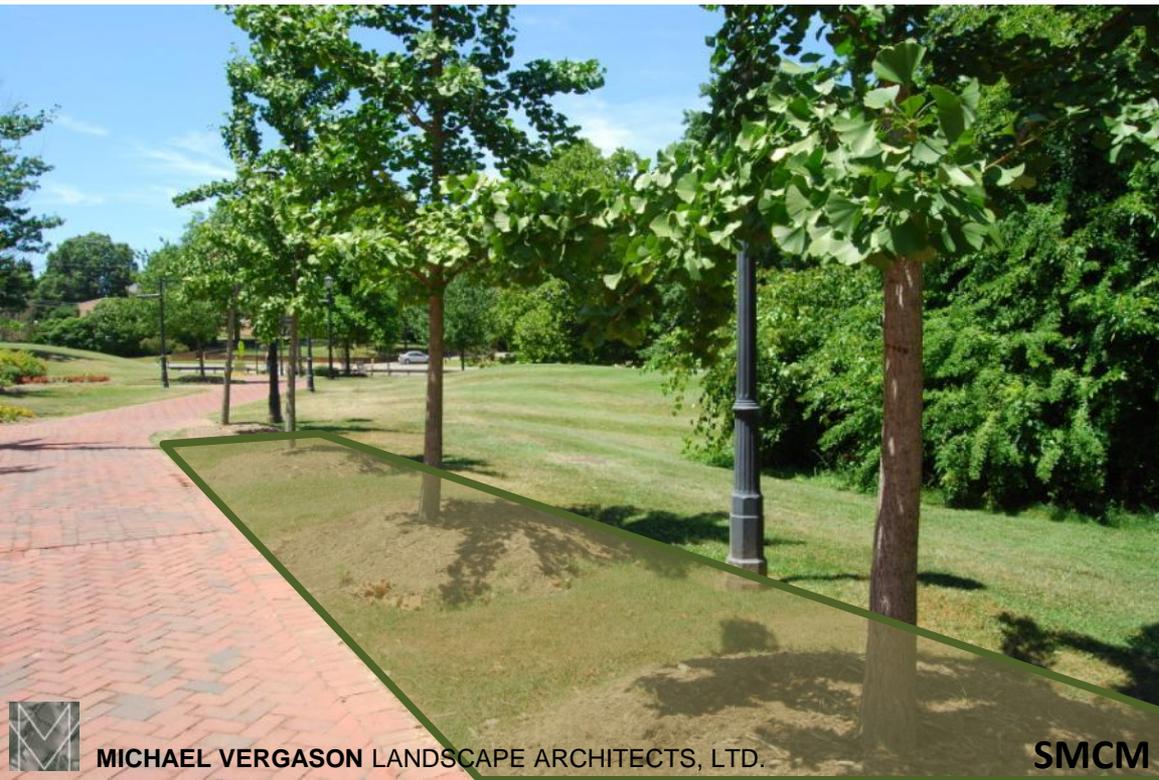
PATH WIDENING

- Main brick walkway through Campus Center needs widening. College is widening brick path in stages as funding allows.
- Future widening in other areas should explore pervious paving on shoulders of path.

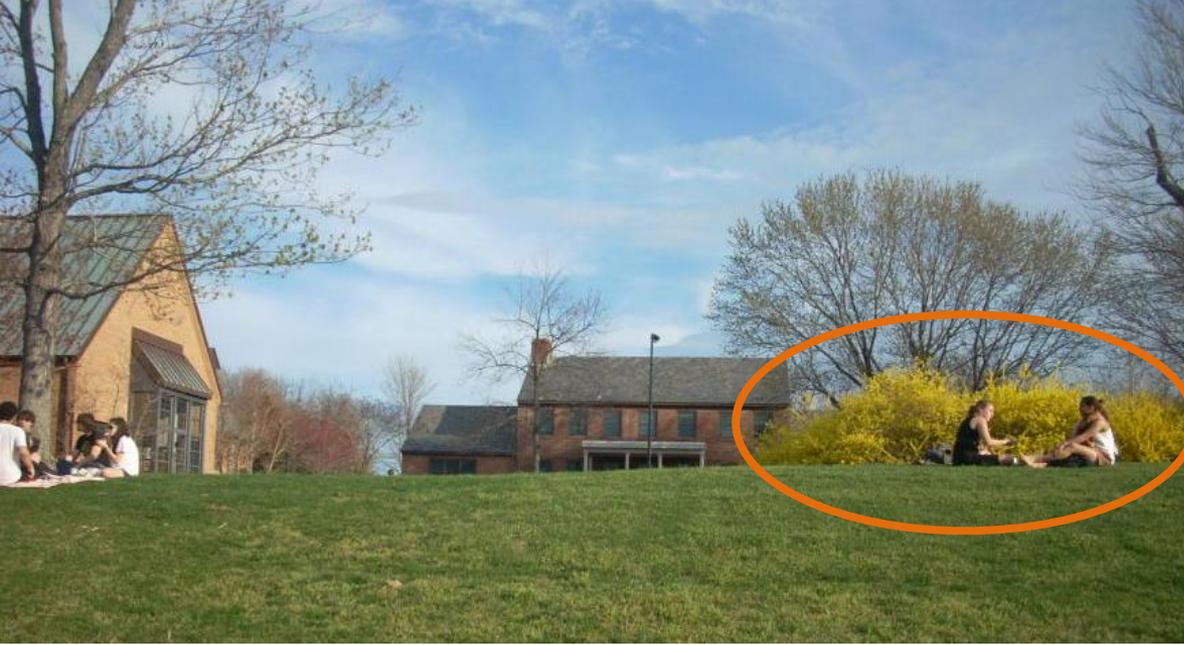
MARGARET BRENT FRONTAGE

- Frontage of MB on the north side needs to be reinforced
- Large forsythia stand obscures sight line toward MB frontage from Rte 5 crosswalk
- Forsythia stand also occupies much of the high point of the knoll, a potential promontory
- Wood deck not full length of porch
- Rain gardens not graded as designed

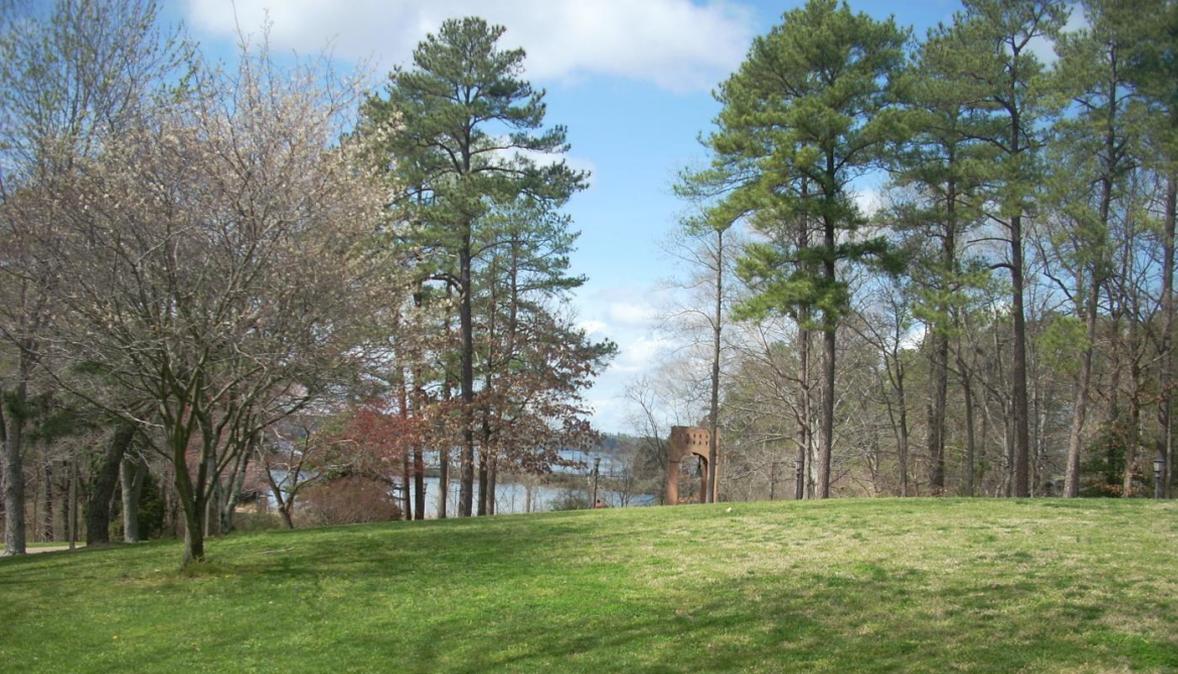
BELL TOWER KNOLL

- Potential space for gathering, including seating
- Address cut-through path at Knoll
