St. Mary's College of Maryland

MASTER PLAN – PHASE 1 SUMMARY

Landscape Needs Analysis and Existing Conditions Assessment

November 1st, 2012

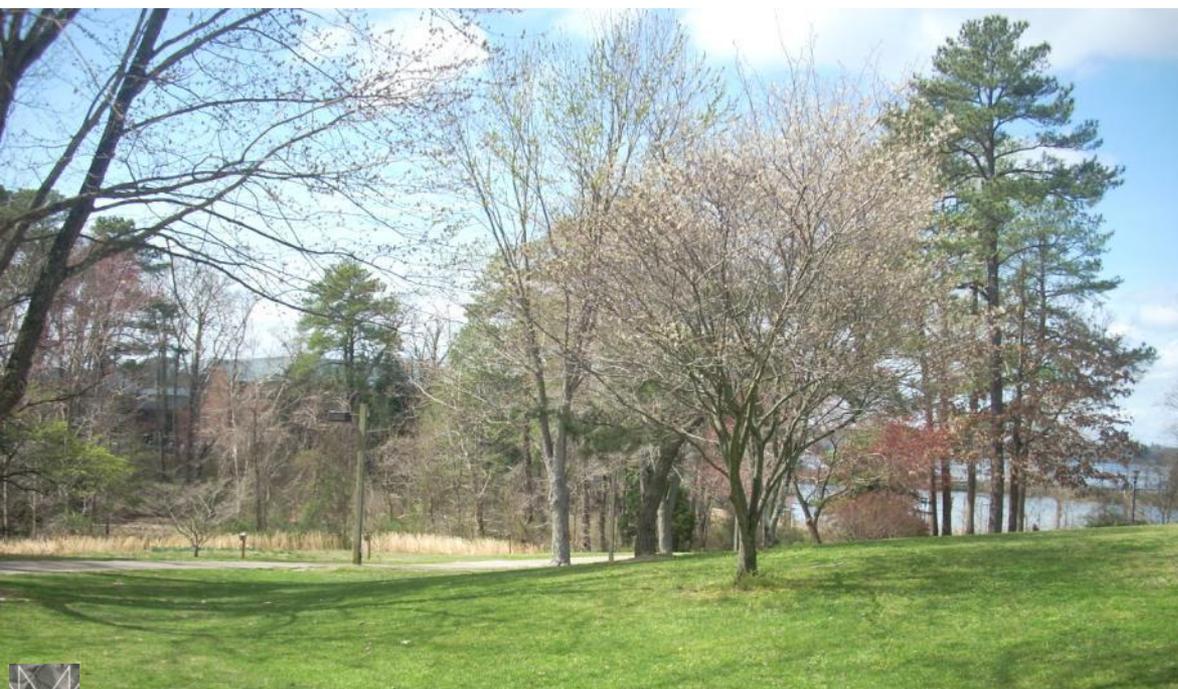
BELL TOWER KNOLL

- Potential space for gathering, including seating
- Address cut-through path at Knoll

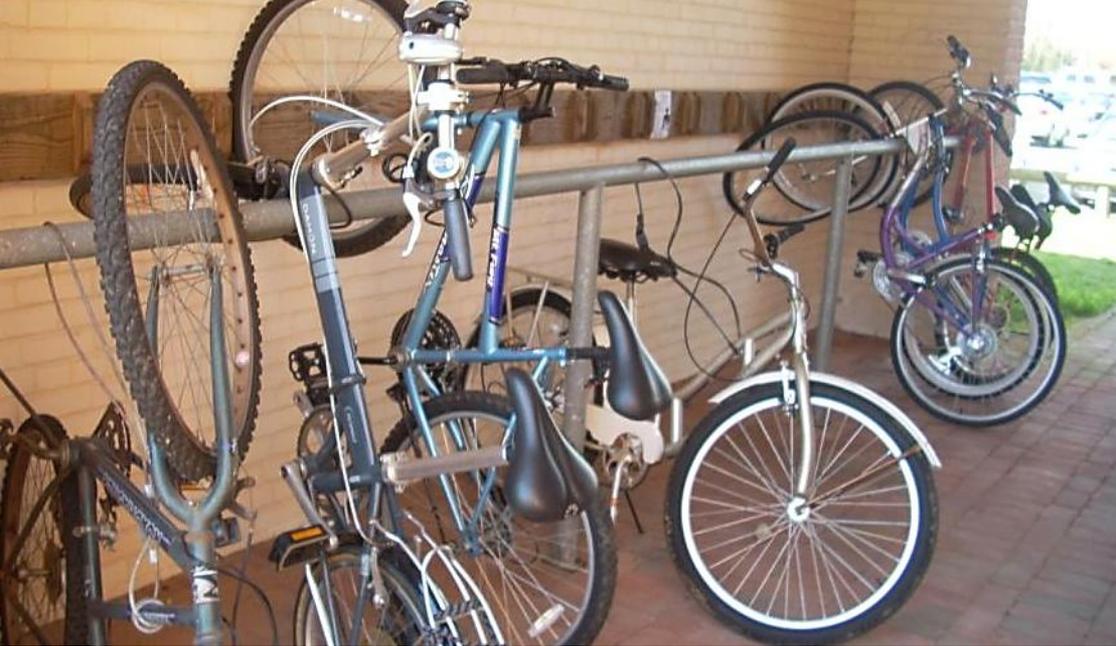
BIKE RACKS

- Additional bike racks desired in this area of heavy use
- Two possible locations discussed

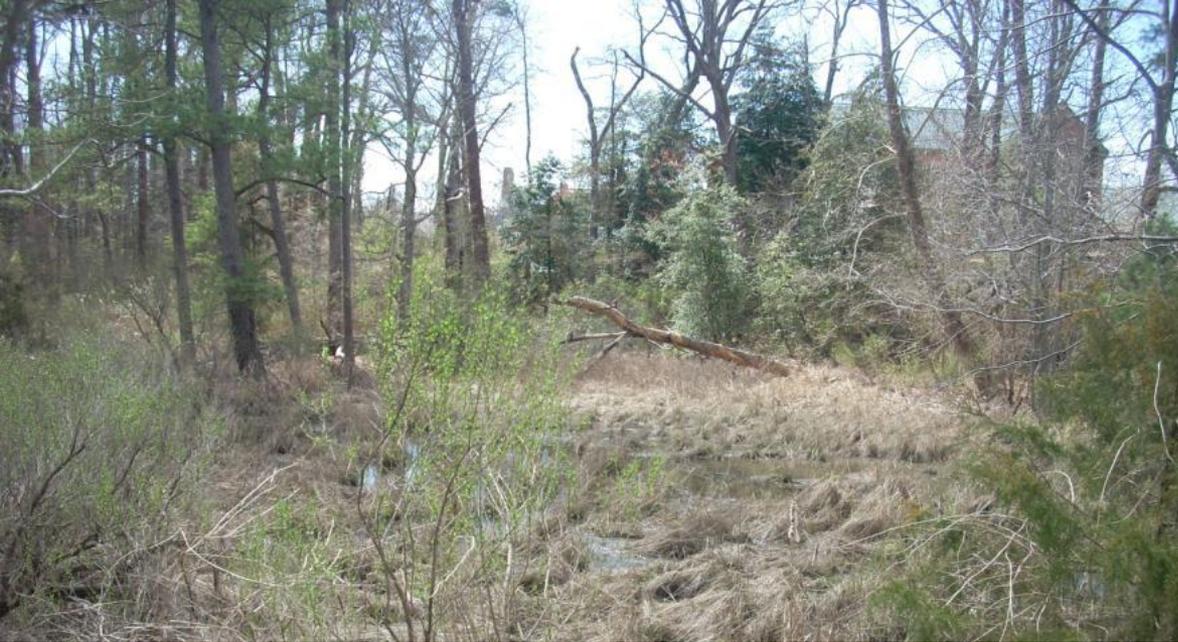
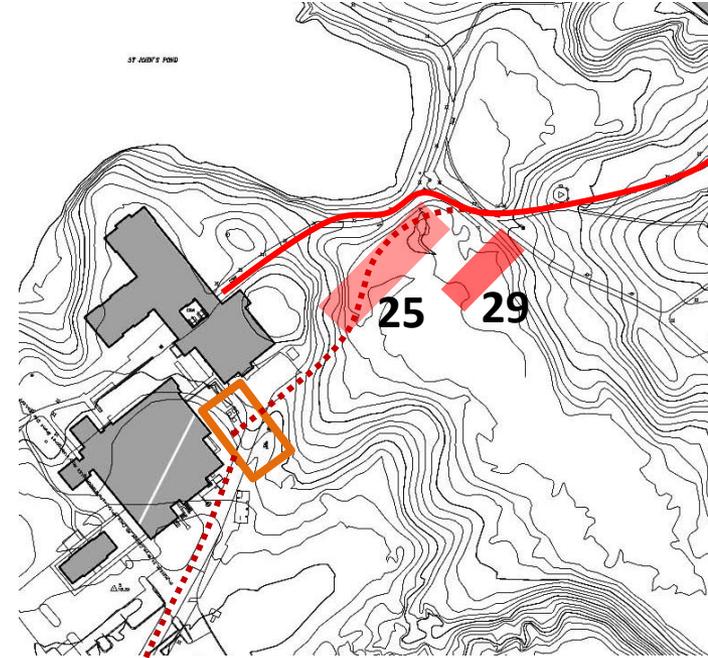
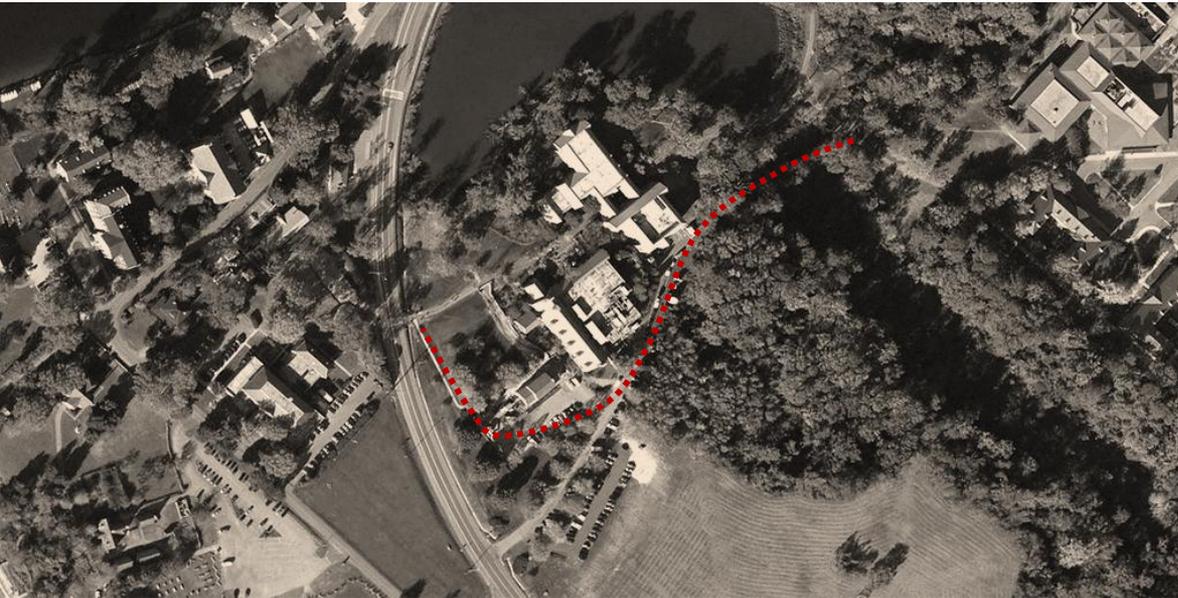
BIKE PATH & BRIDGE, PIER ACCESS

- Conflicts between bicyclists and pedestrians may not be completely resolved with main walkway widening
- Possible alternate route through marsh with boardwalk trail
- Teaching / research access to marsh from pier
- Trail could end at another bike storage area or continue to Mill Field Lot and pick up path close to Route 5.

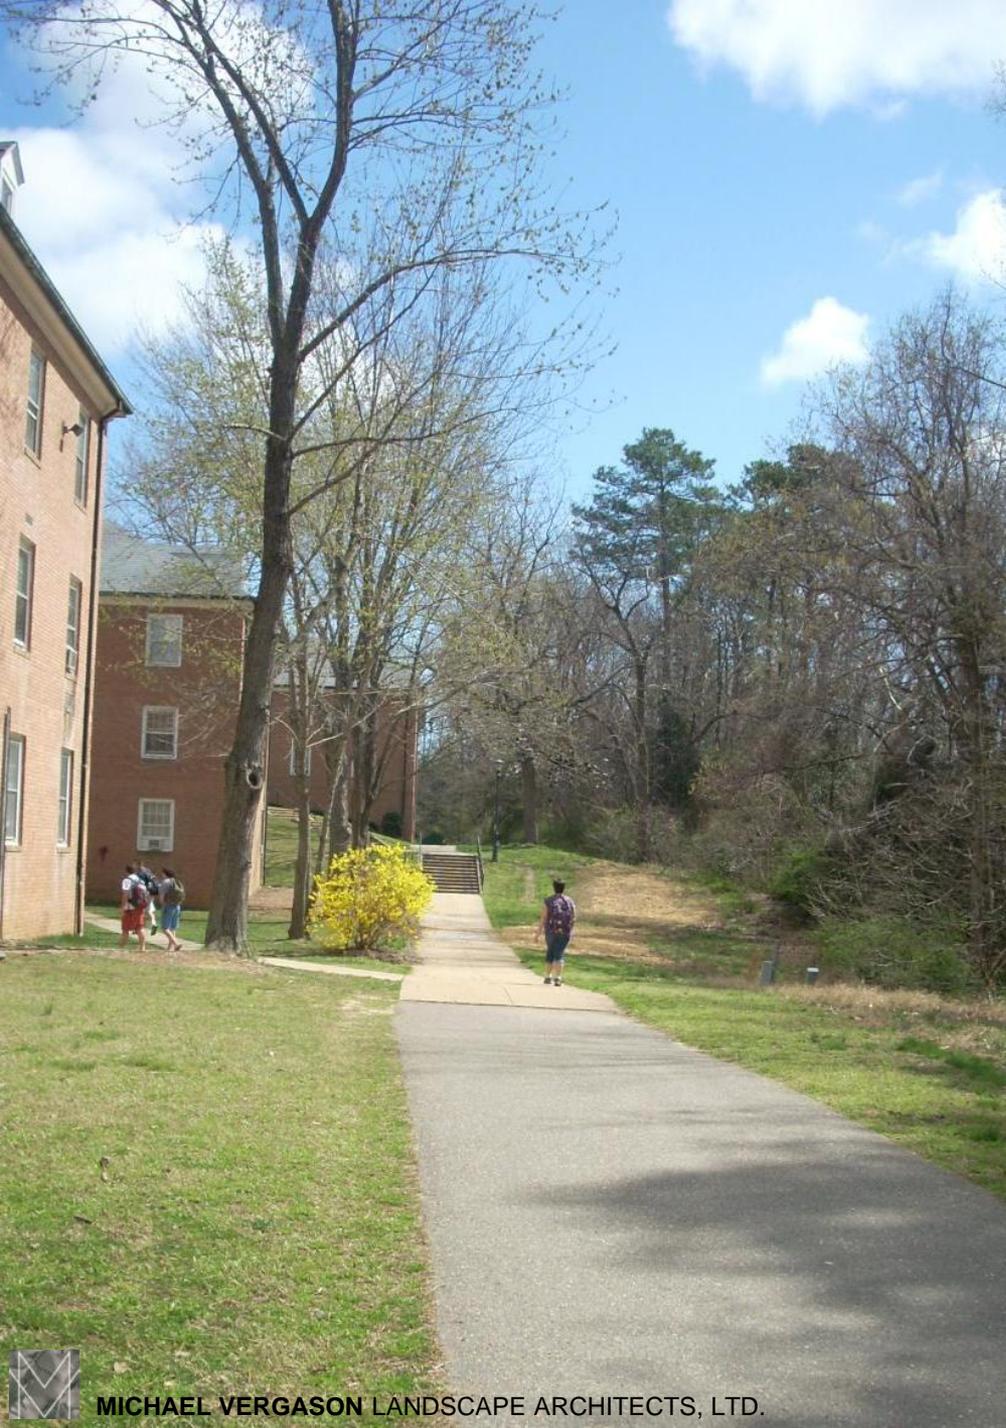
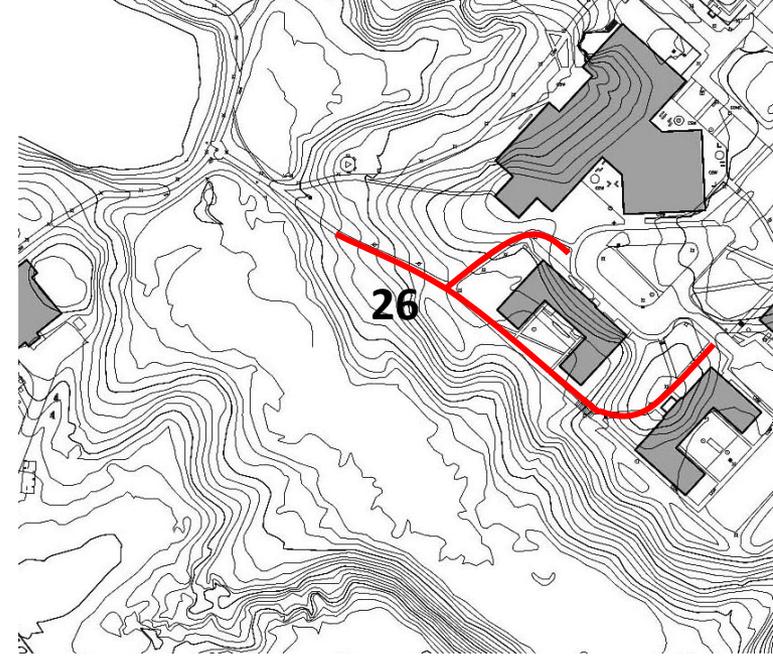
PATH TO DORCHESTER

- Existing path changes from asphalt to concrete at Dorchester Hall.
- Path material should be consistent.
- Suggested material should be asphalt or brick, not concrete
- Path currently accommodates vehicular traffic; it should be limited to pedestrian traffic

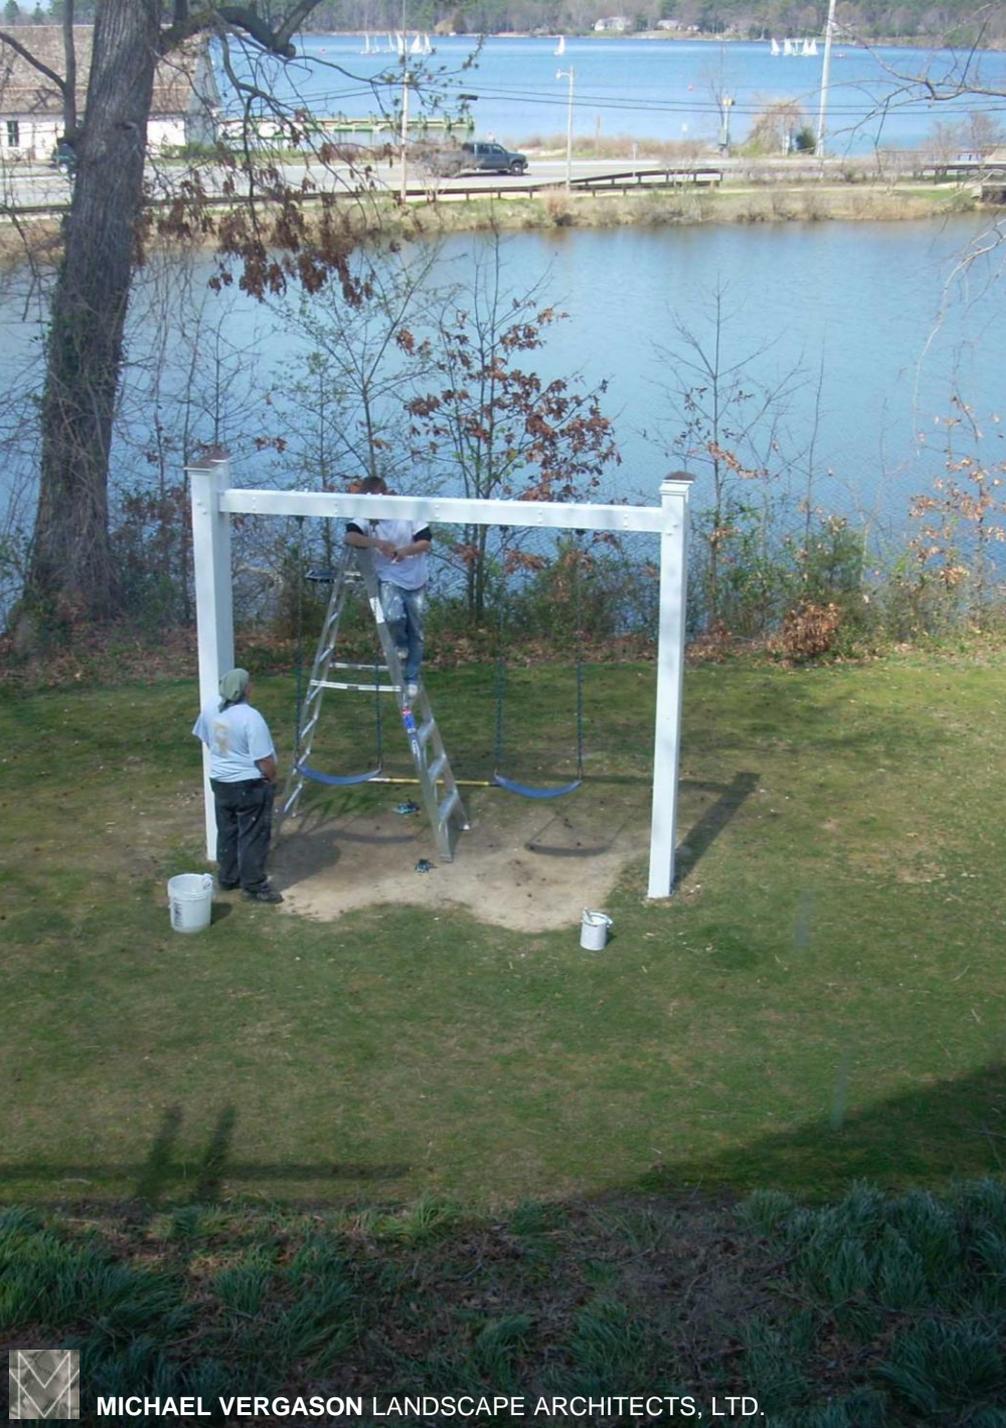
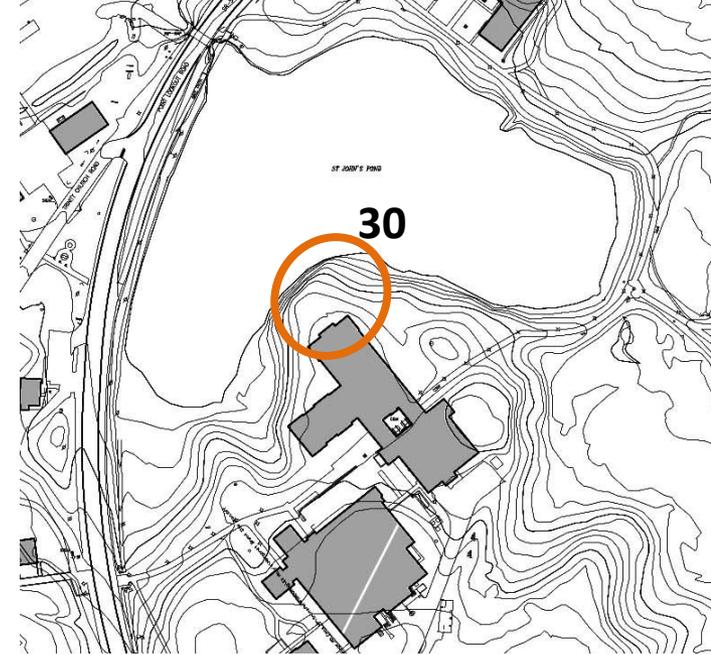
SEATING AREA AT ST. JOHN'S POND

- Add seating, enhance buffer and plantings
- Improve access to area

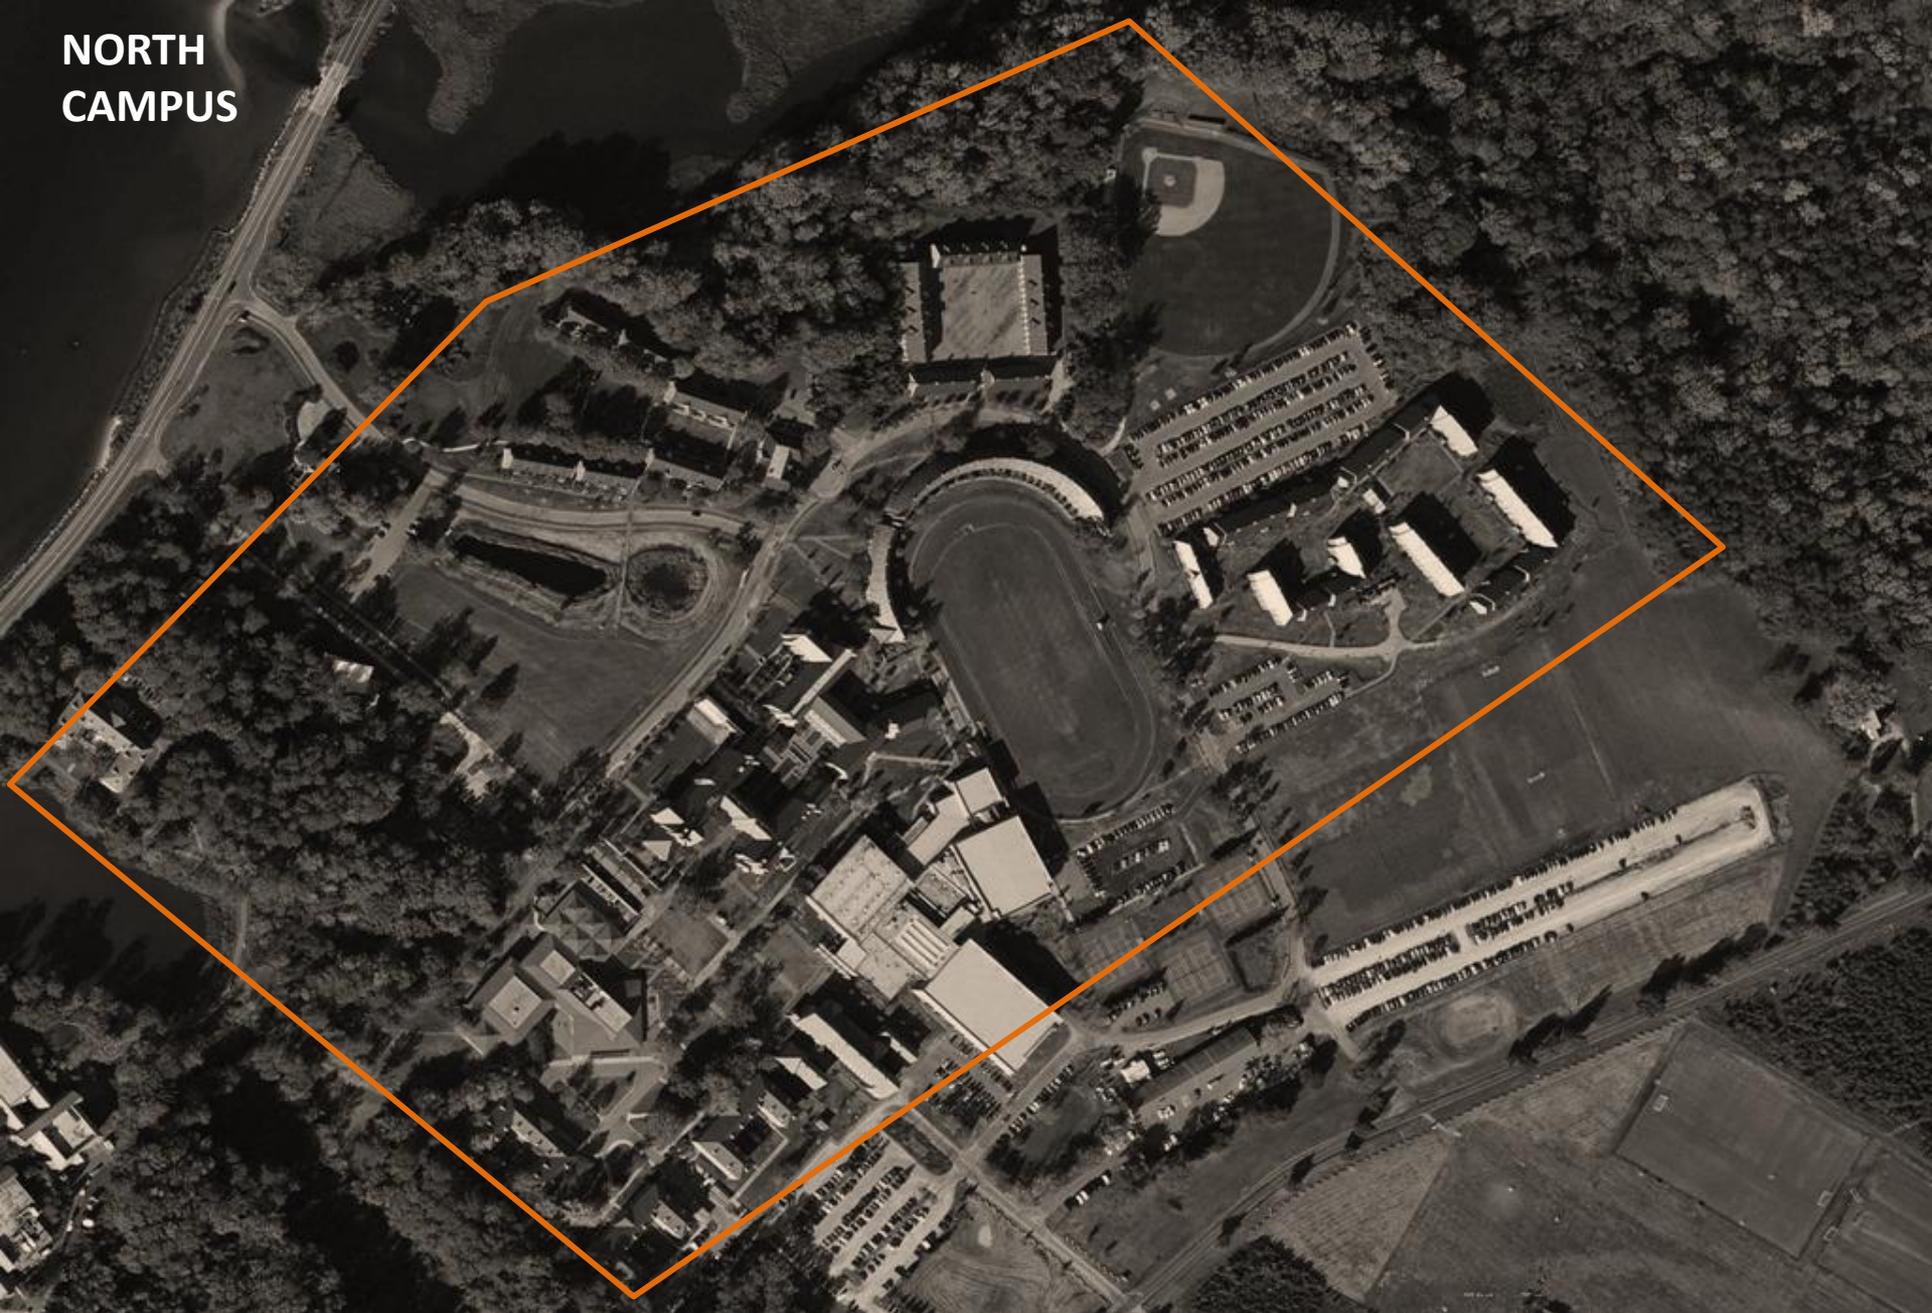
NORTH CAMPUS PROJECTS

- 31. Montgomery Quad improvements
- 32. Soils study
- 33. Soils improvement
- 34. Irrigation and stormwater management
- 35. PG Hall improvements
- 36. Caroline Hall improvements
- 37. Townhouse Green improvements
- 38. Baseball Field improvements
- 39. Lewis Hall improvements
- 40. Queen Anne Hall - trees
- 41. Fisher's Creek promontory
- 42. Fisher's Creek crossing
- 43. St. John's grounds improvements

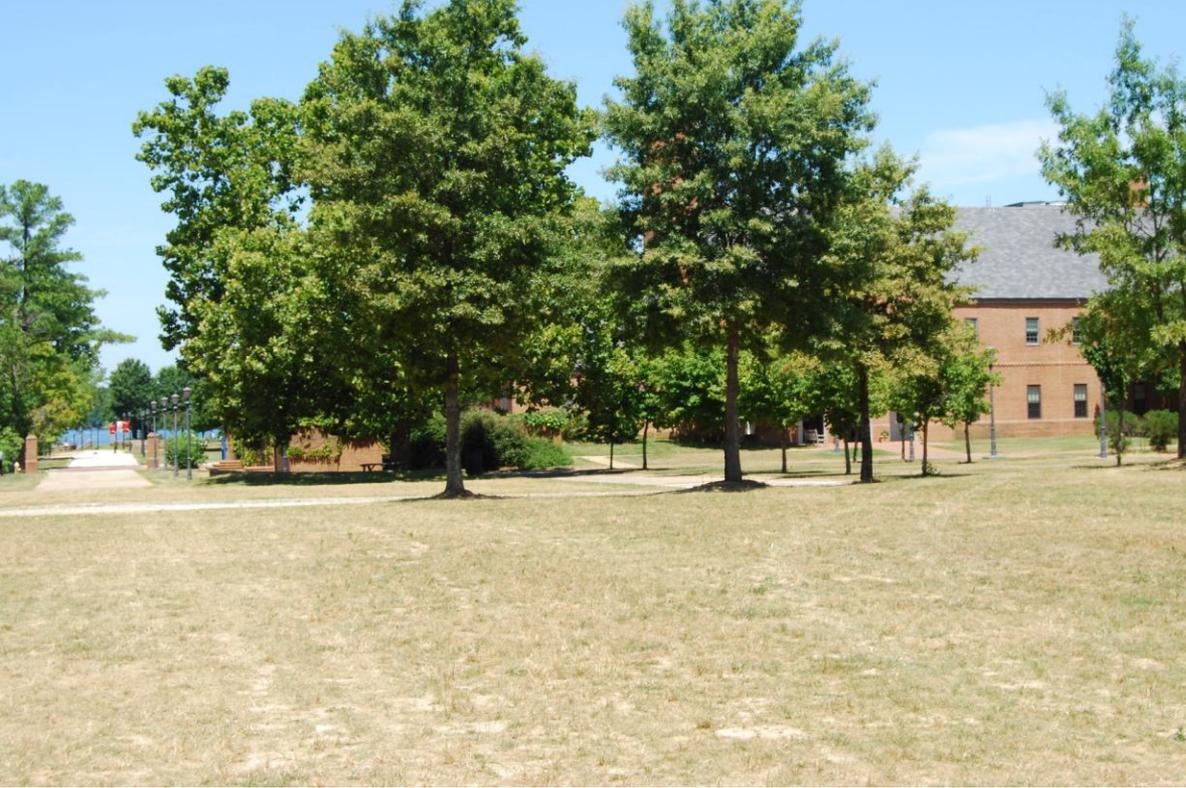
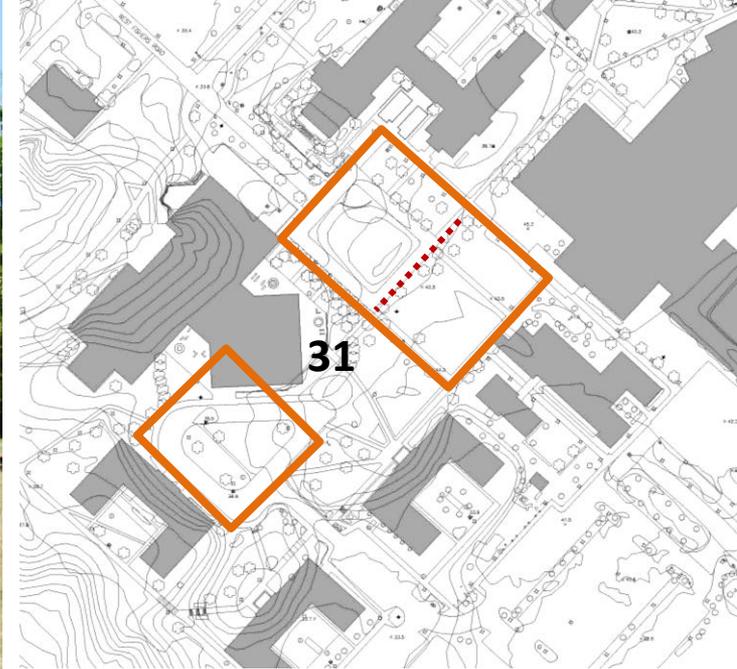
MONTGOMERY QUAD

- Selective tree removal
- Drive resurfacing
- New edge planting
- Terrace (gravel) at annex
- Add shade trees
- Add furniture
- Improvements at Dorchester Circle

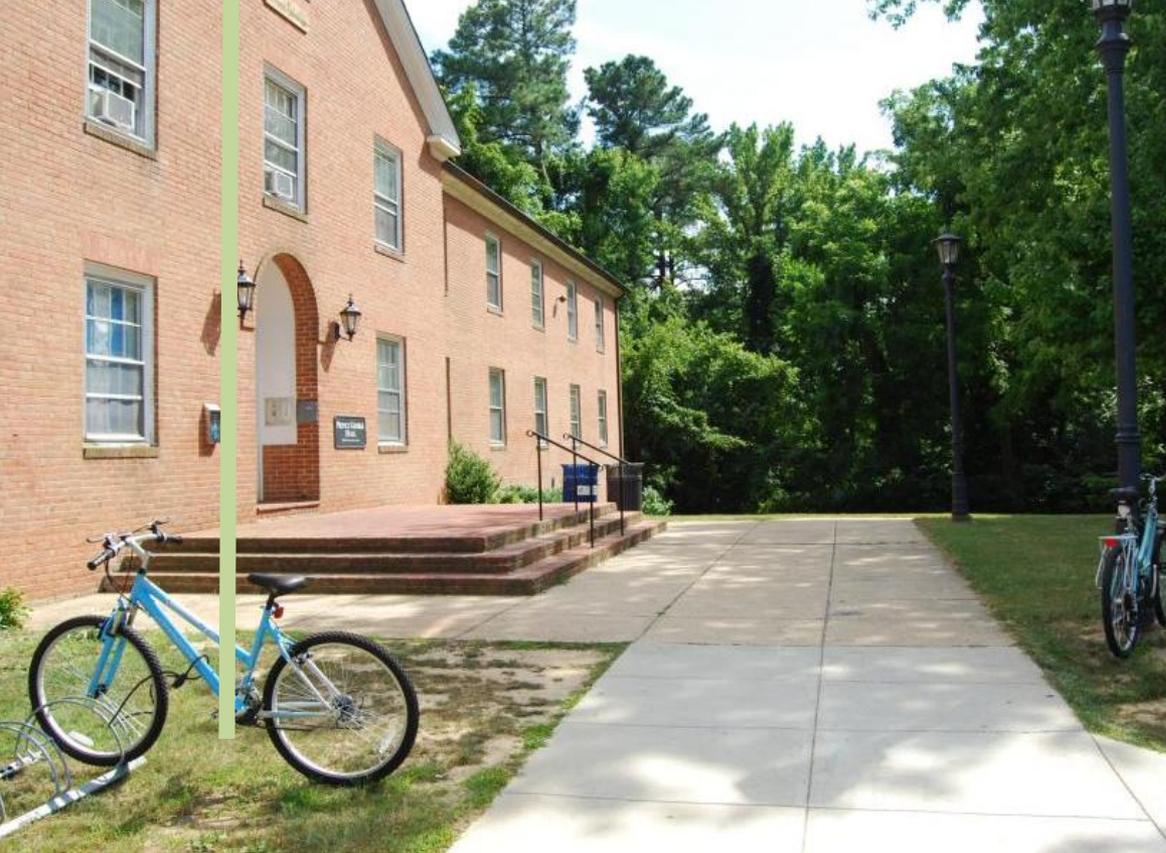
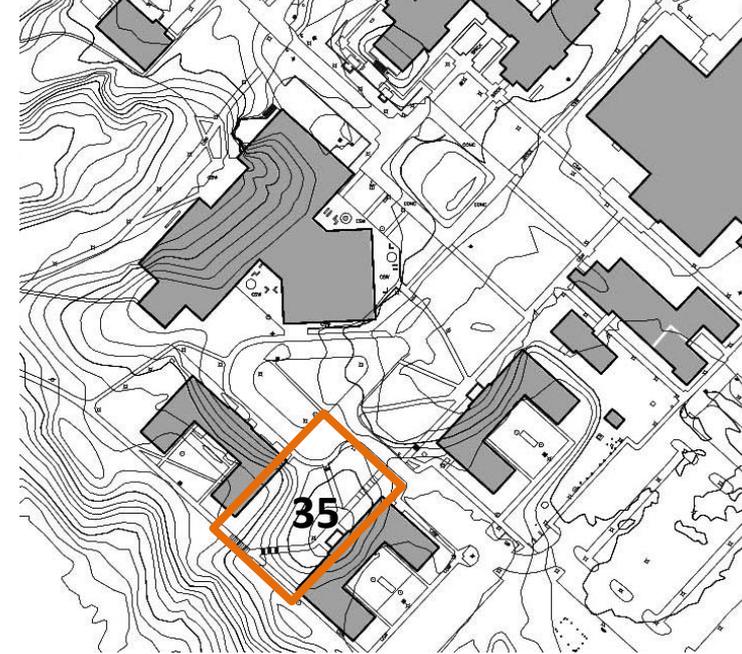
PG HALL

- Add shade trees
- Add benches
- Add bike racks

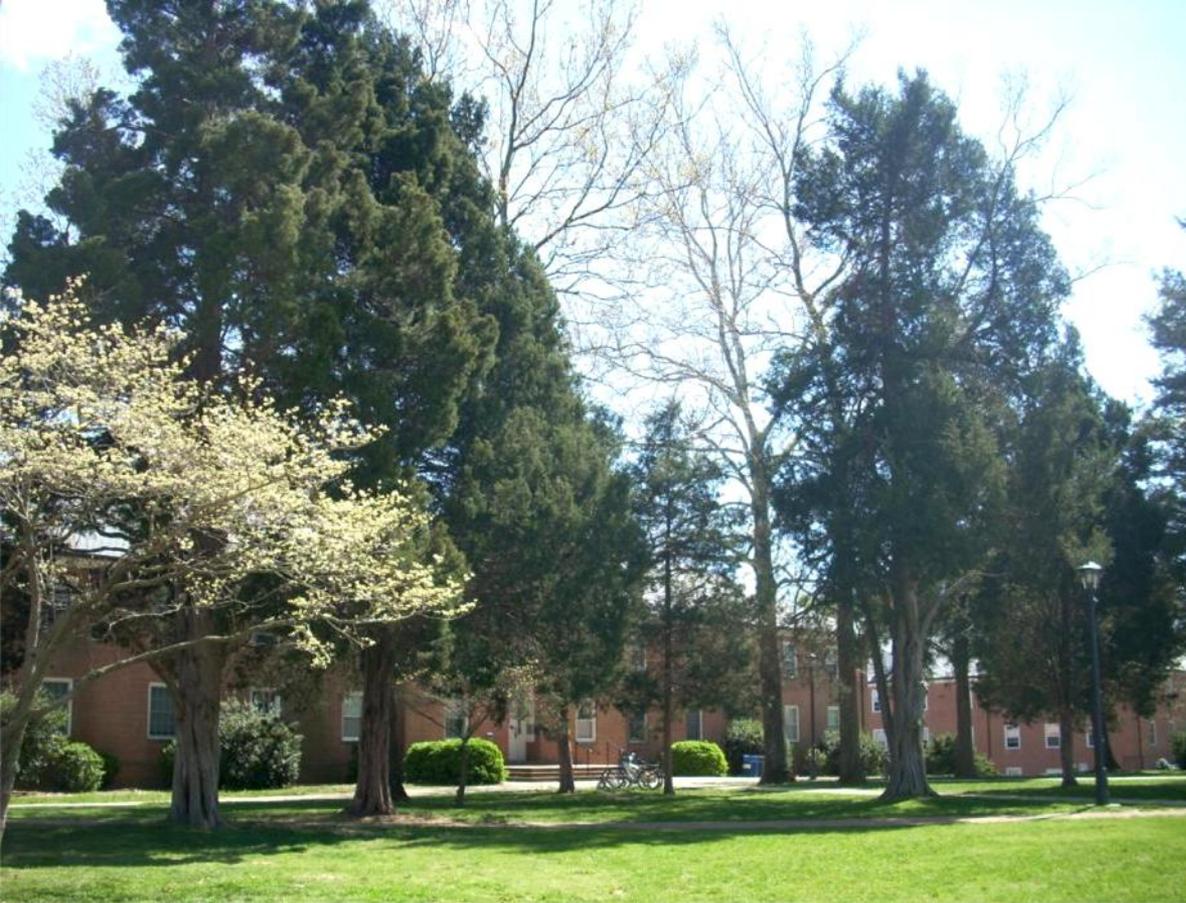
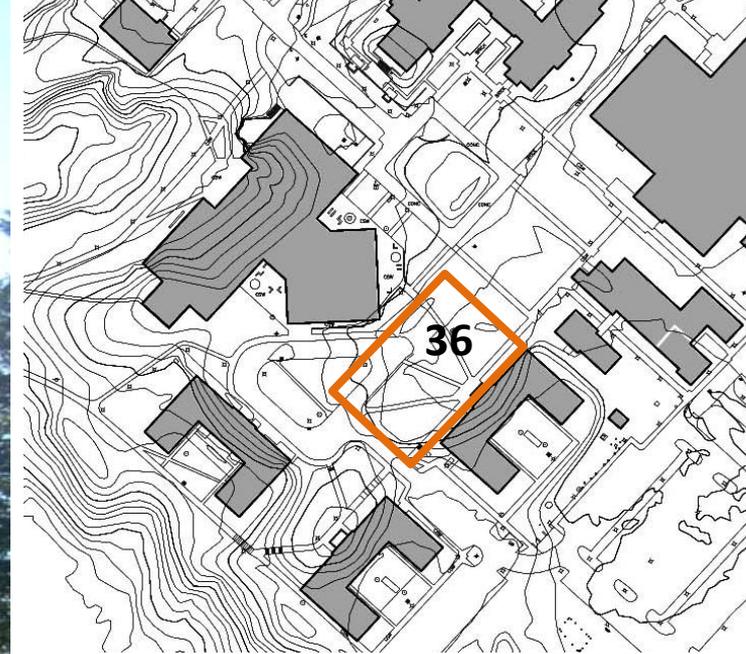
CAROLINE HALL

- Add benches
- Add moveable chairs
- Expand tree canopy

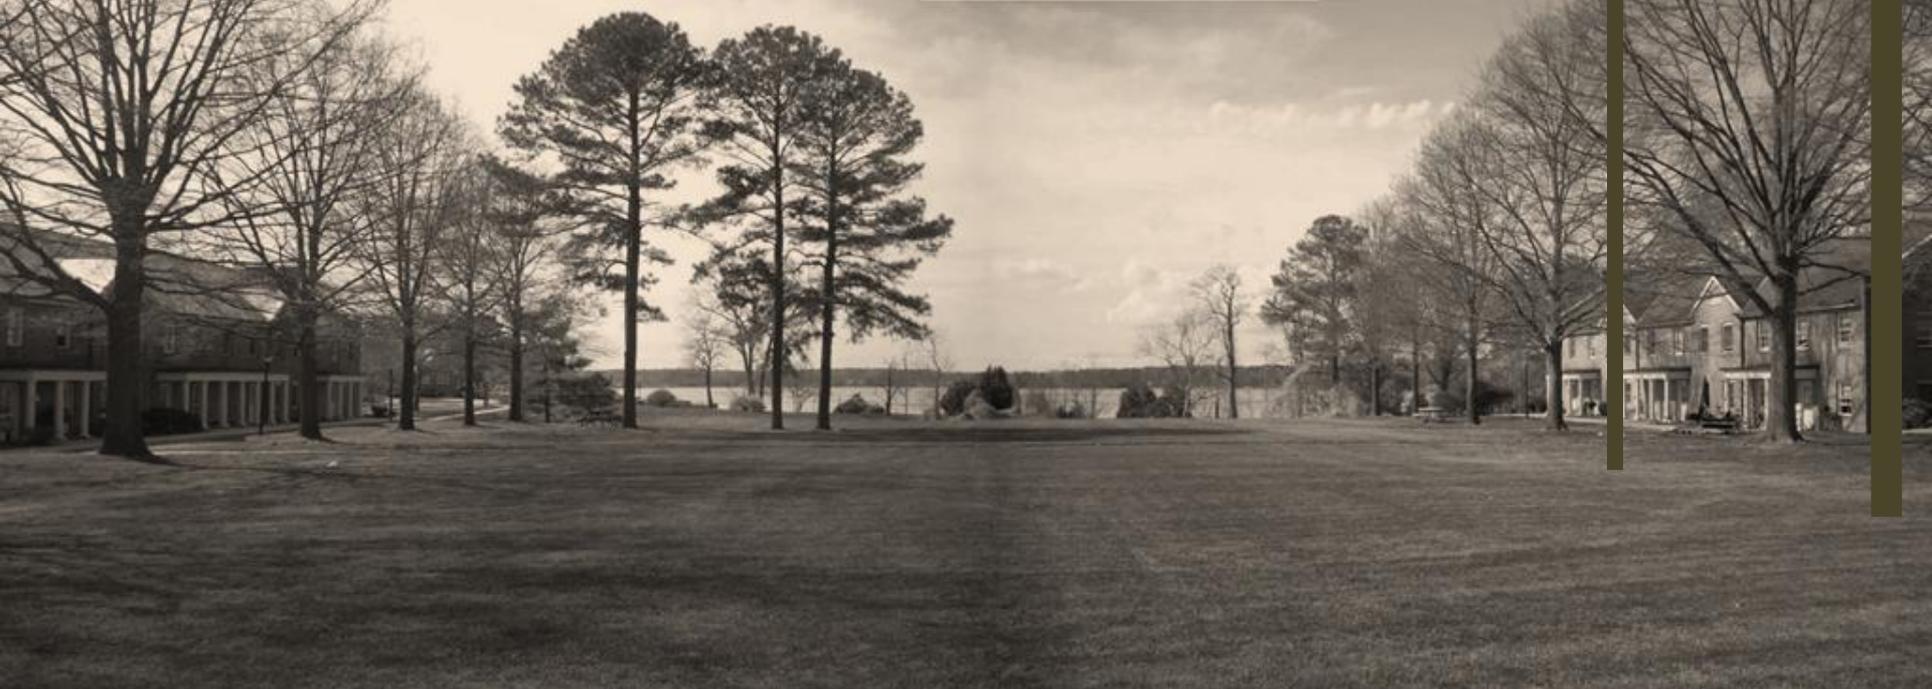
TOWNHOUSE GREEN

- View to water
- Planting – mix of regular deciduous shade trees and random evergreen trees

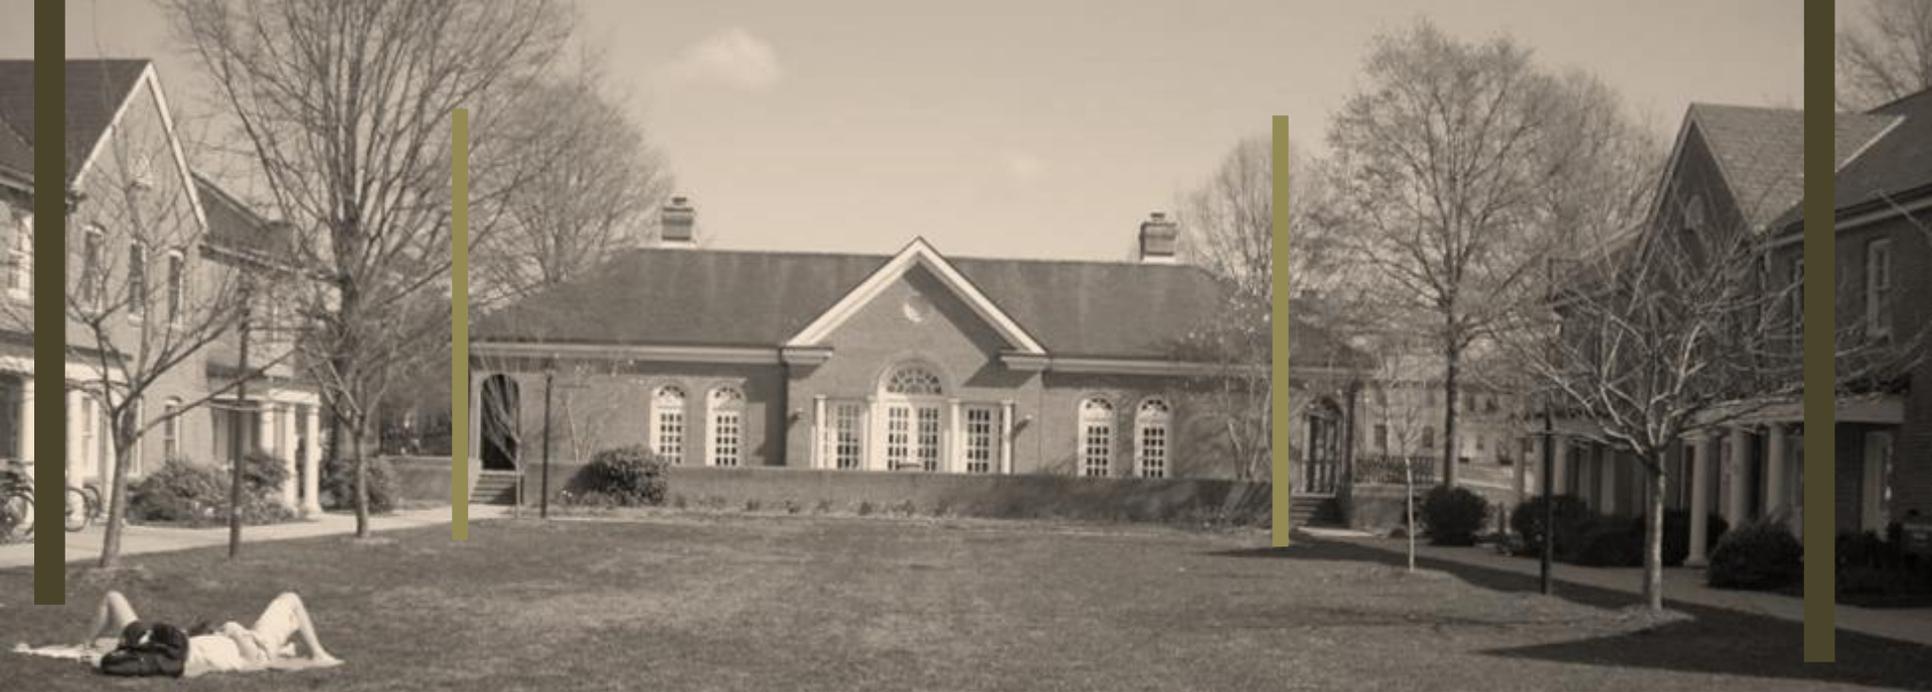
TOWNHOUSE GREEN

- Add regular deciduous shade trees
- Replace existing cherries?

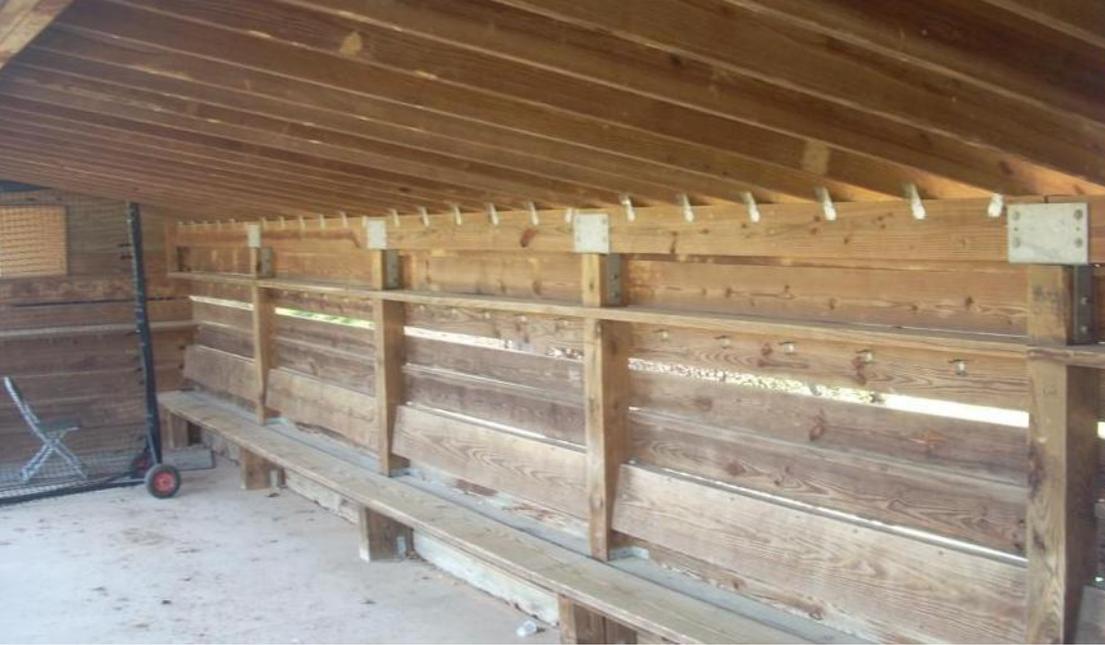
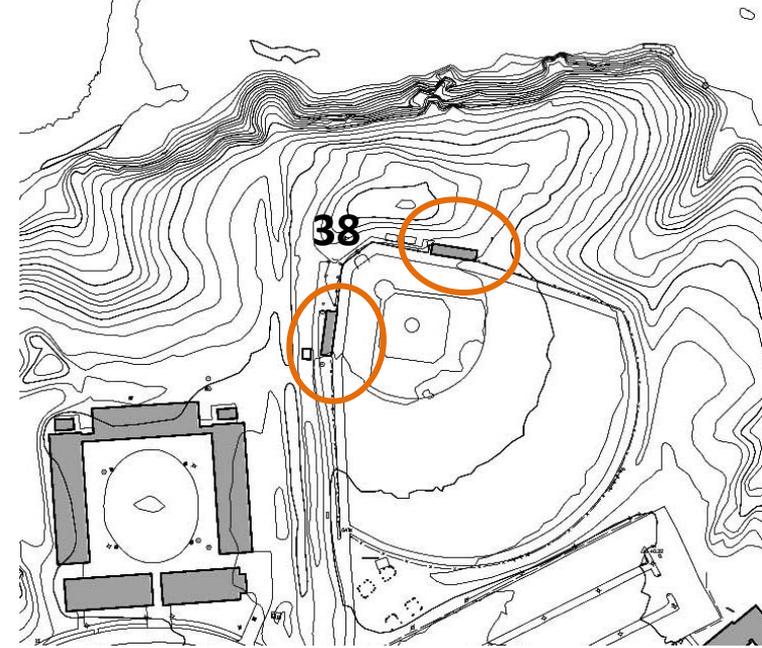
BASEBALL FIELD

- Paint dugouts Charleston Green
- Expand storage

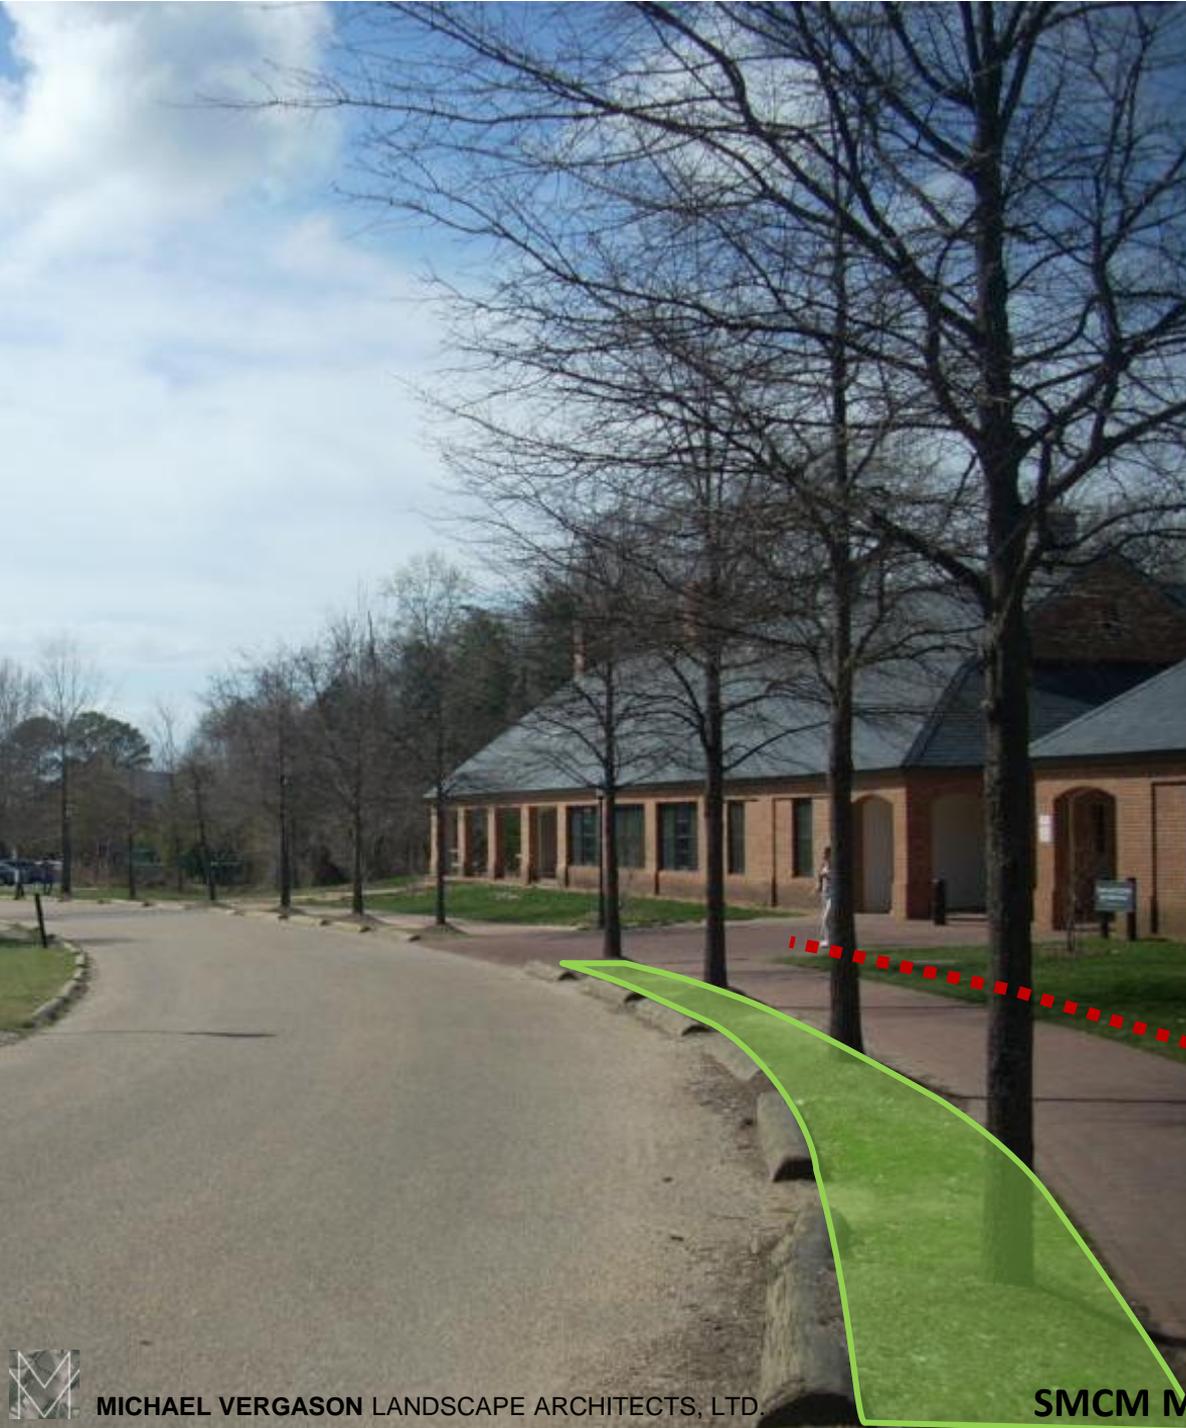
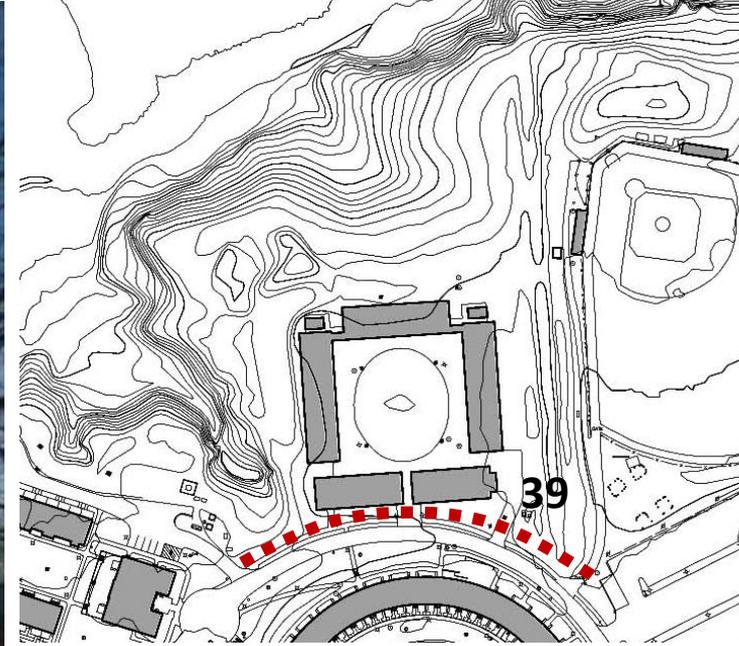
LEWIS HALL IMPROVEMENTS

- Mulch existing row of trees
- Add trees on other side of walkway; avoid duct bank
- Address circulation at porch end

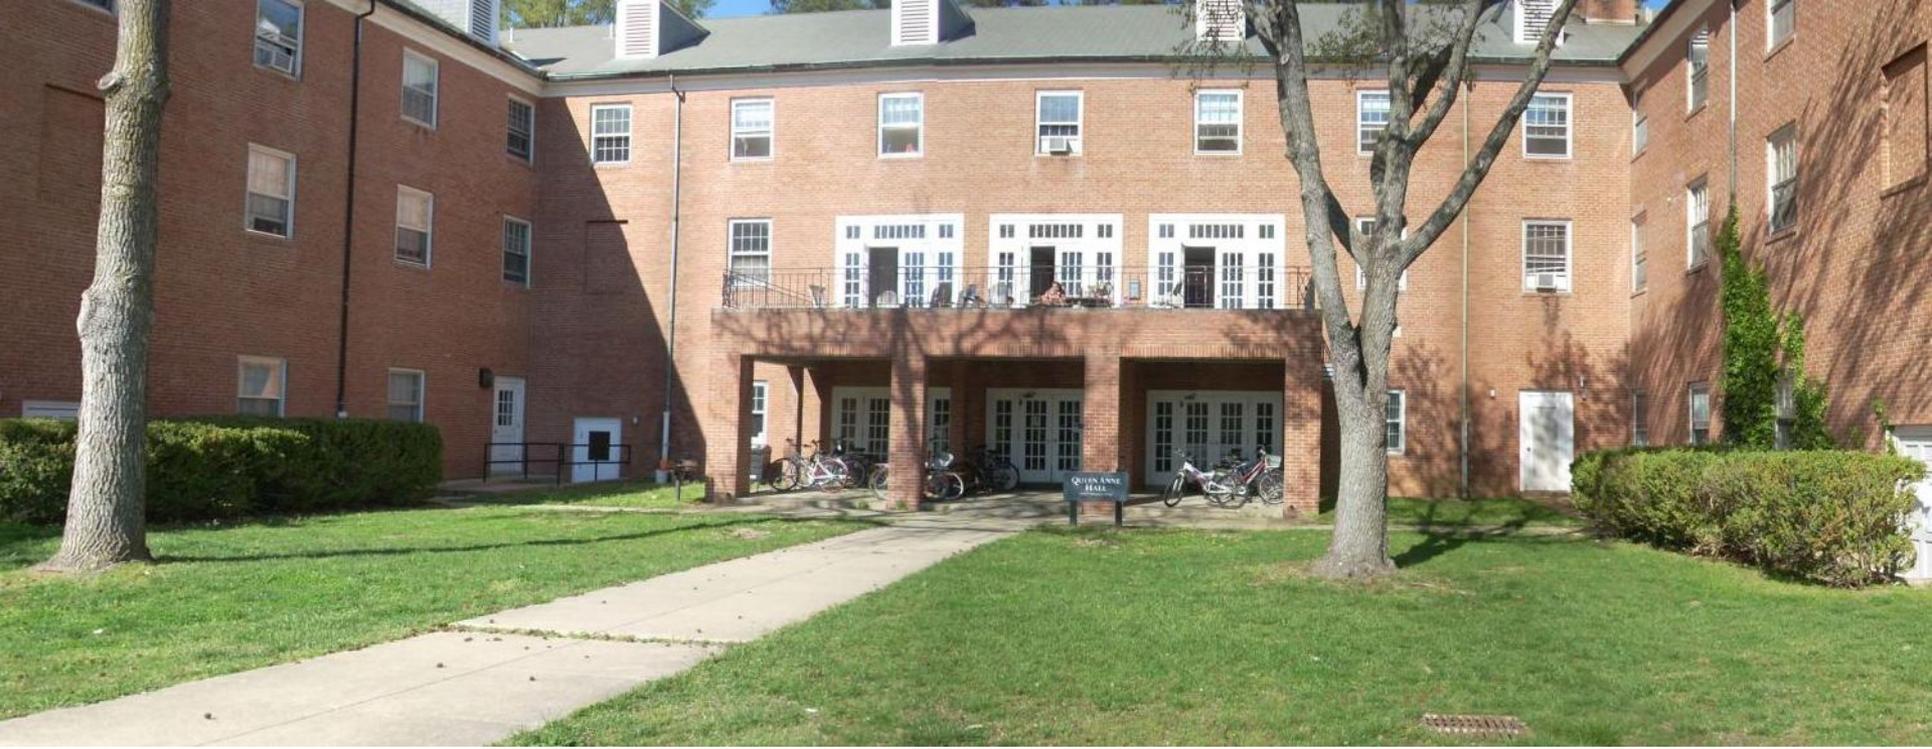
QUEEN ANNE HALL

- Add trees to expand tree canopy
