St. Mary's College of Maryland

MASTER PLAN – PHASE 1 SUMMARY

Landscape Needs Analysis and Existing Conditions Assessment

November 1st, 2012

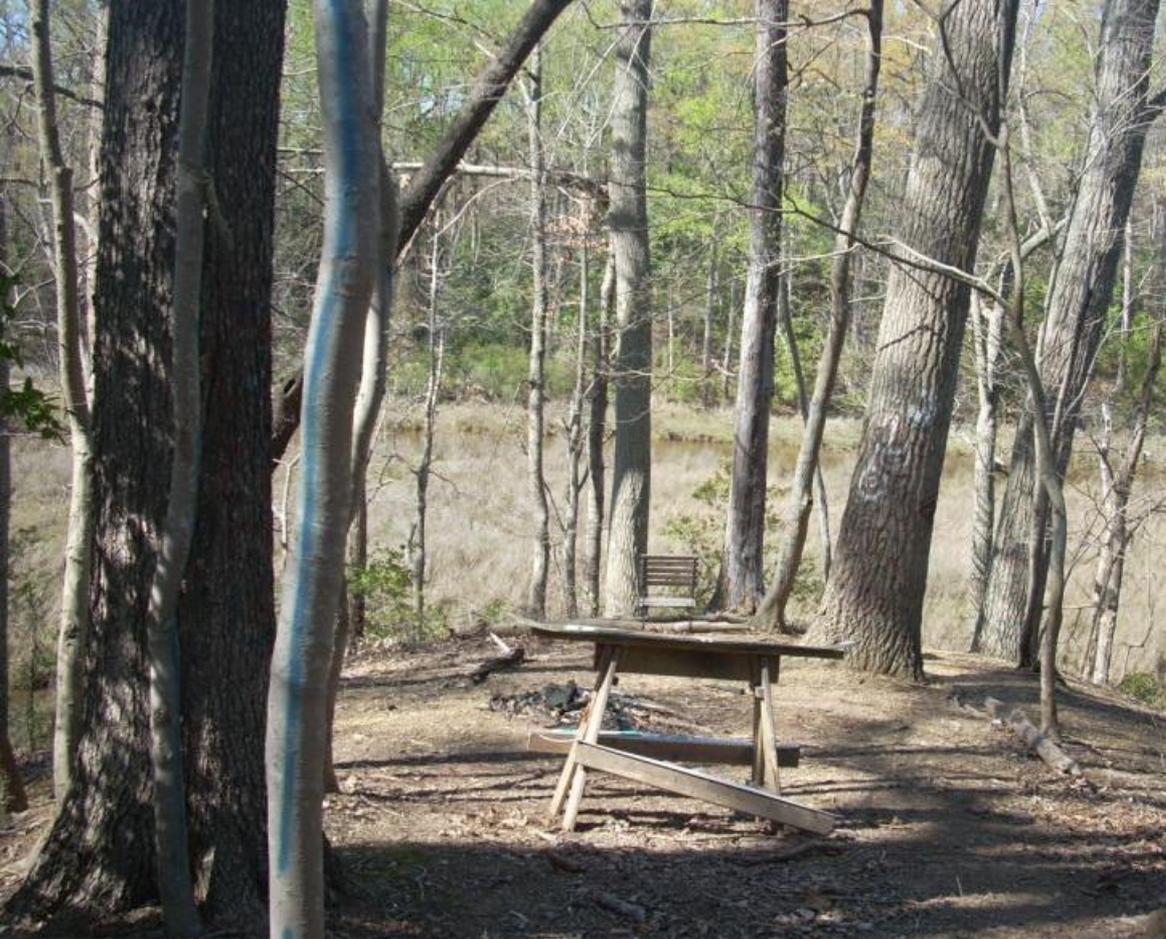
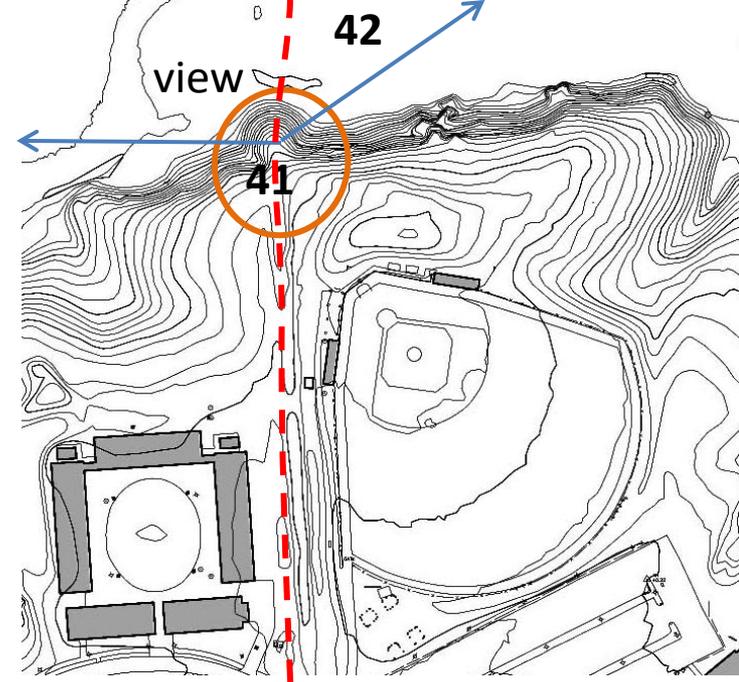
FISHER'S CREEK

- Promontory
- Connection - across Fisher's Creek to North Fields
