Capital Design Advisory

MD. Route 5

Traffic Calming & Safety

St. Mary's College of Maryland Facilities Master Plan, 2011-2026

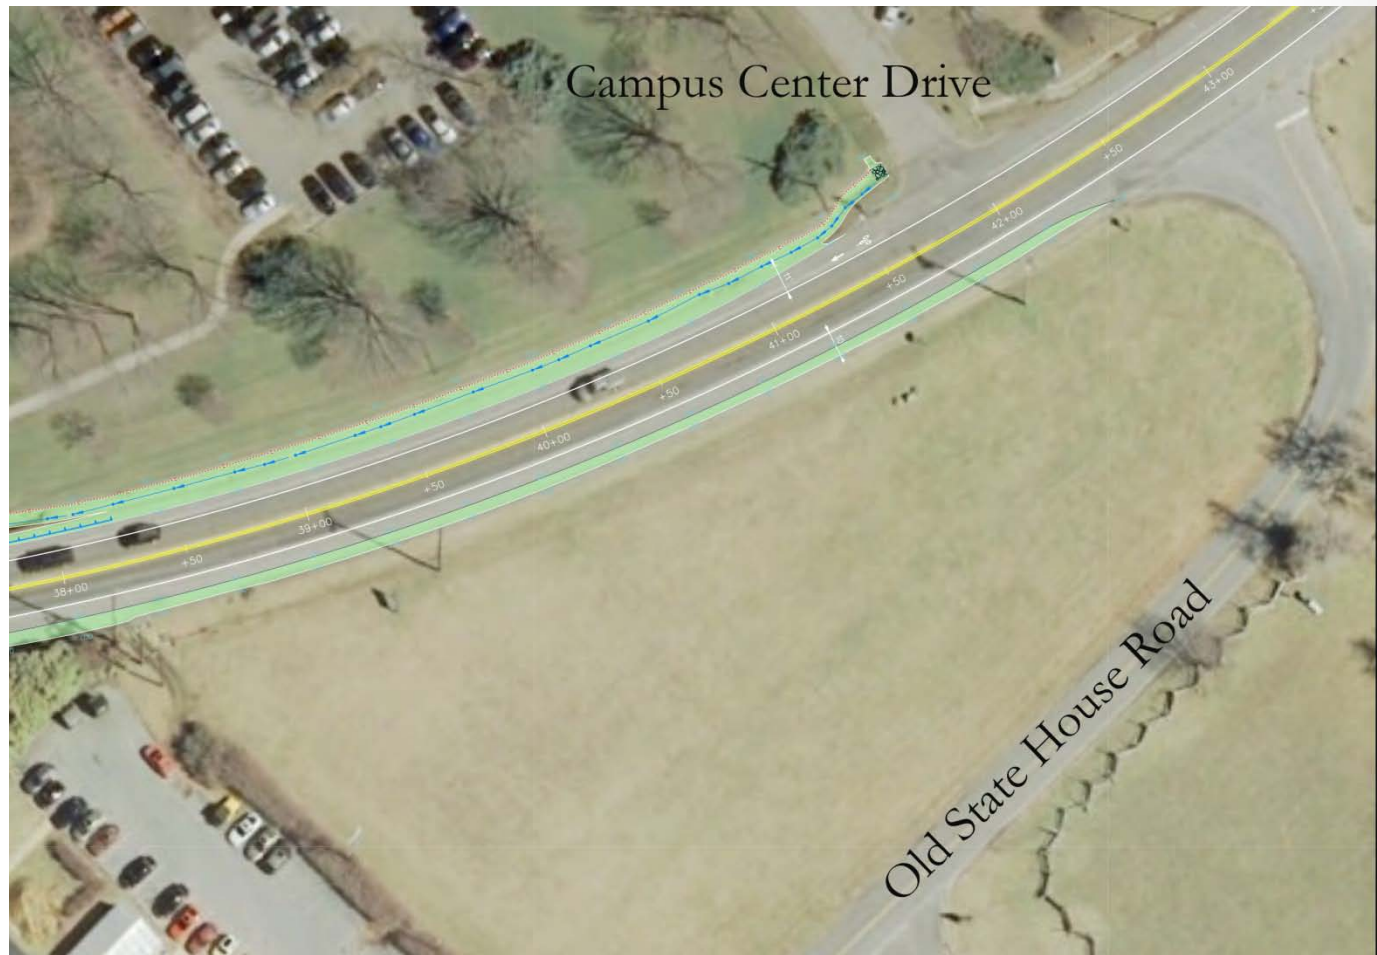
South End of Project

- Pavement narrowing transitions 100' north of Campus Center driveway
- Bike lanes terminate at State House Rd.

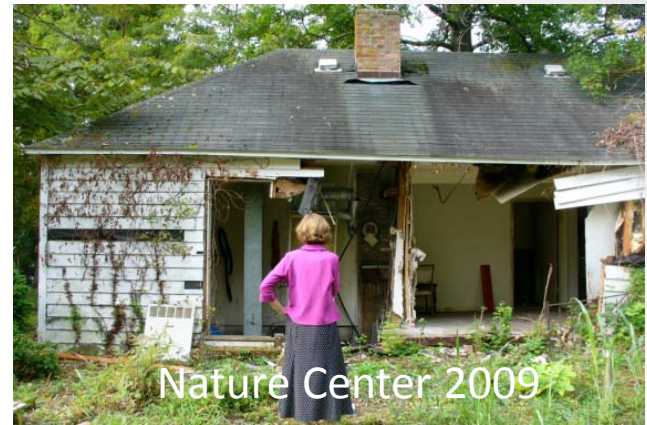
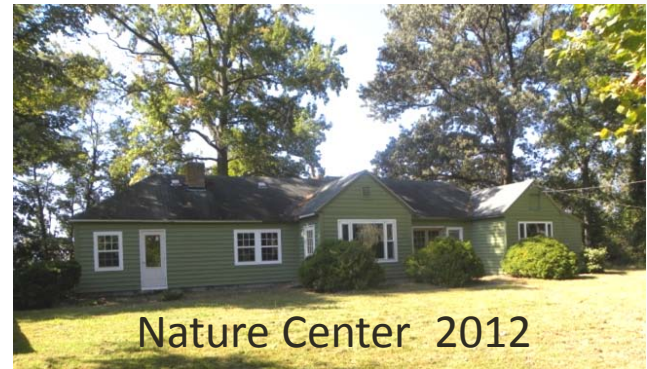
Chancellor's Point at Historic St. Mary's City

- 66 acres on the St. Mary's River
- Nature Center destroyed due to vandalism
- Rehabilitation underway
 - *Repair Nature Center*
 - *Road Reconstruction*
 - *New ADA paths to Nature Center*
 - *New ADA access path to shoreline and beach*
